# Fuel Operations After Natural Disasters

*Experiences From The Industry*

1st Edition  
Effective 1 February 2018

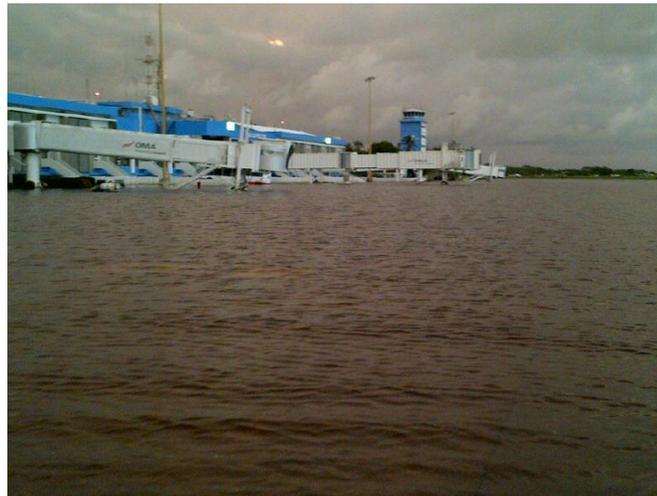
Once the weather situation stabilized, ASA initiated actions to assess the damages caused at the Fuel Farms. In a general perspective, the infrastructure and equipment damages were low but the airport located in Acapulco had considerably damages caused by the flood.

Figure 3-Flood, Acapulco Airport

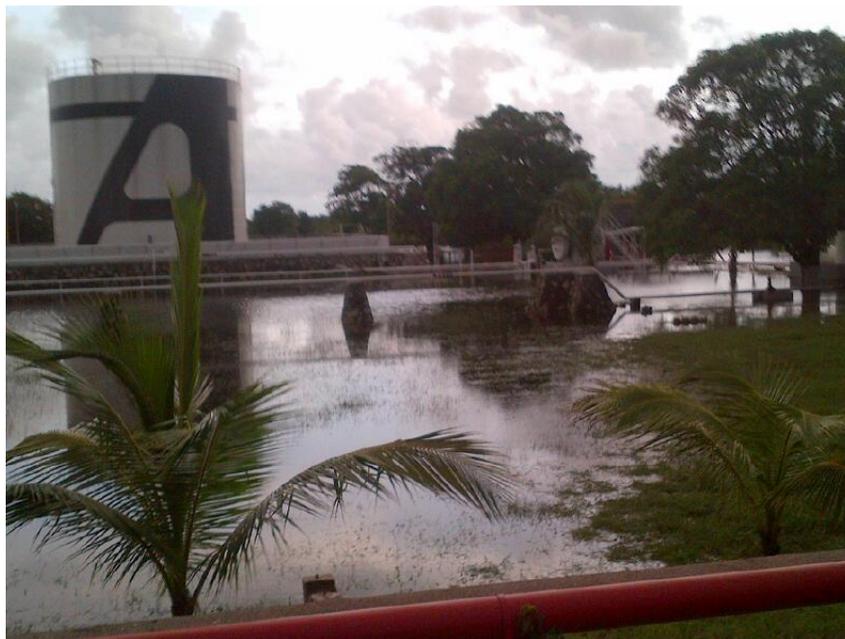
Also, the fuel farm at that airport had floods, but with no high impact in its operation.

*Figure 4-Flood, Fuel Farm, Acapulco Airport*

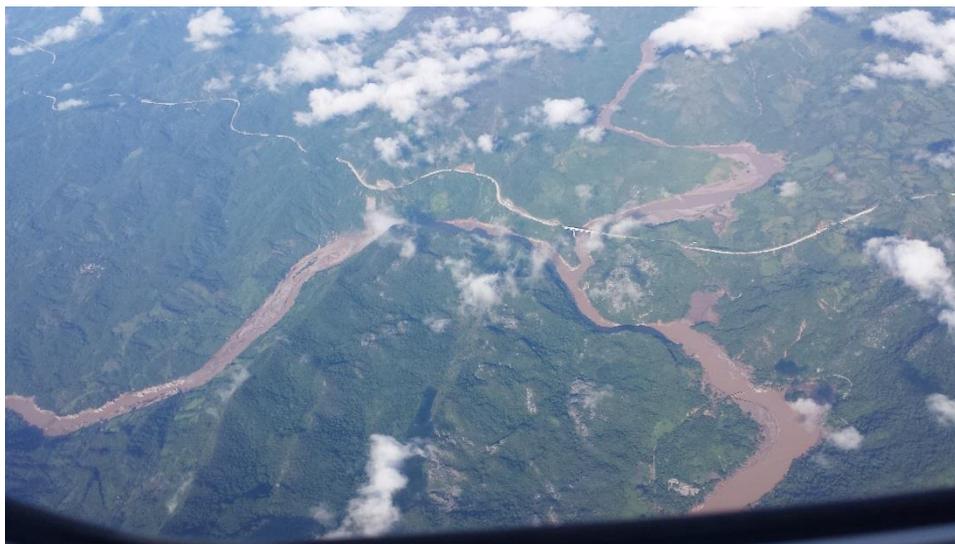
*Figure 5-River overflow, Guerrero, near Acapulco Airport.*

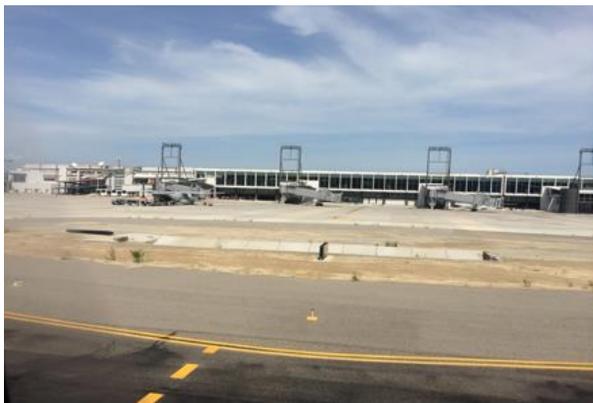
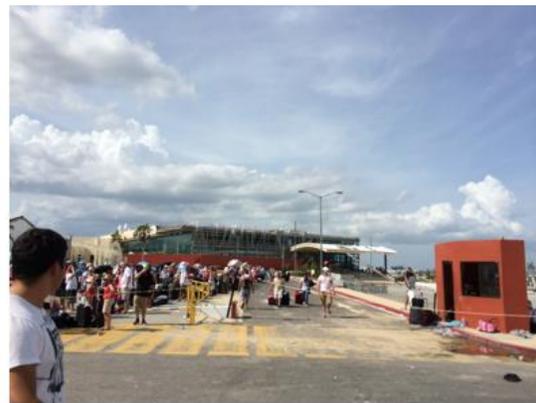
The airport encountered serious damage in the area of passenger terminals as well as in the control tower and support equipment, however, the runway and airport platform were not demolished.

*Figure 8-Damage in terminals, SJD Airport.*

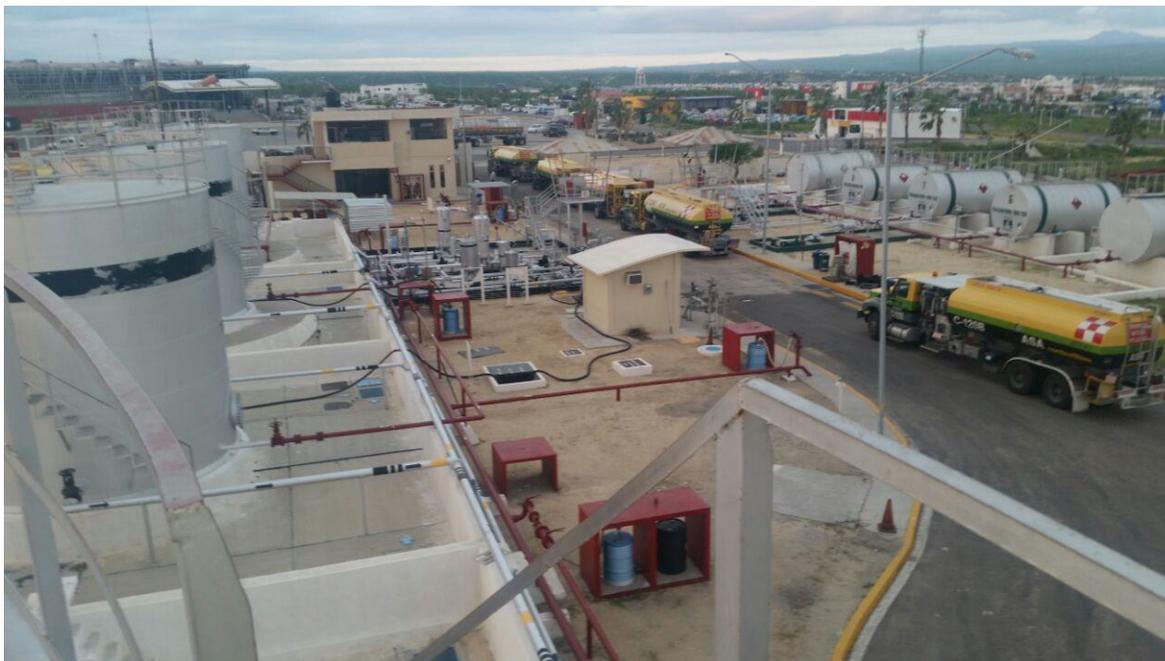
The area of tanks had minor impacts; nevertheless, the hydrants system suffered flooding and minor consequences by sand and wind.

*Figure 9-General view, SJD fuel farm, after the hit of the Hurricane.*

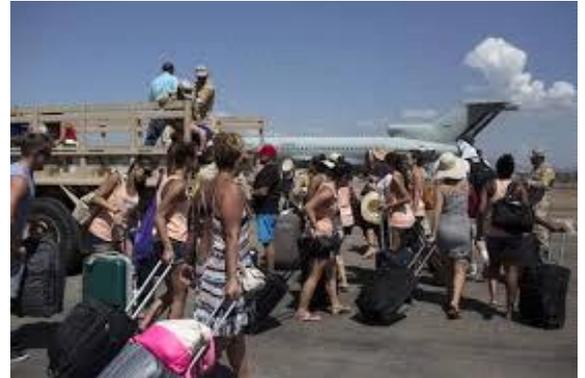
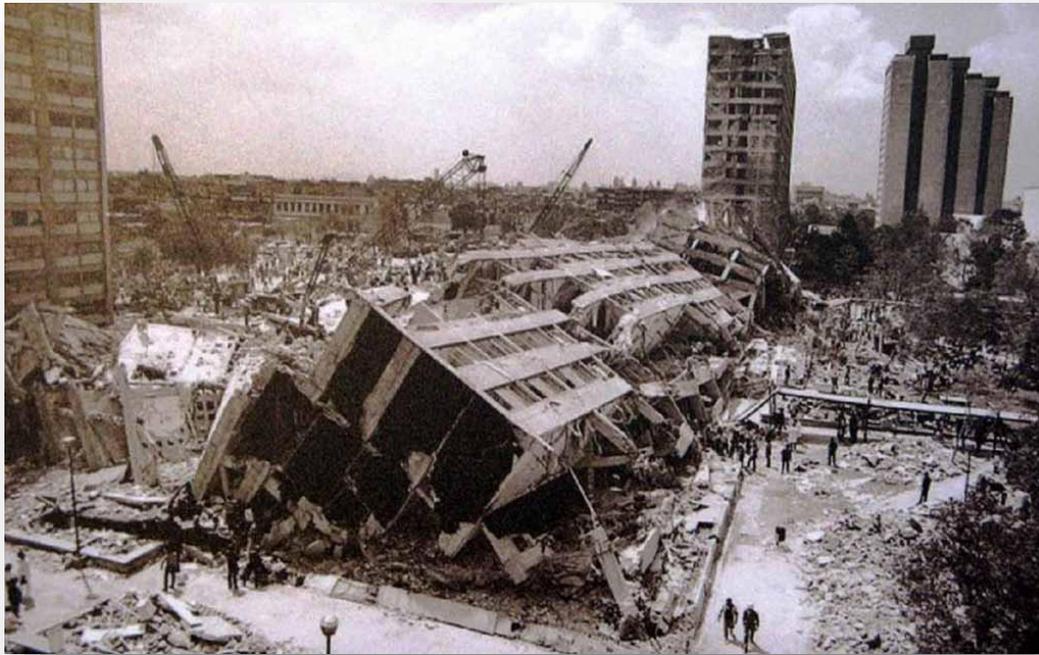
*Figure 10-Damage in residential buildings, Mexico City, 1985*

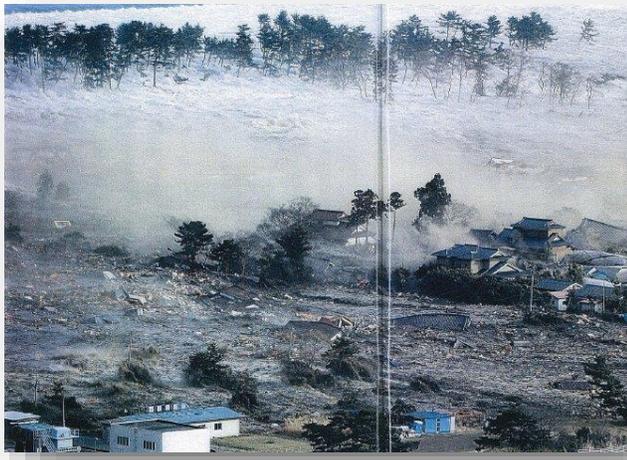
Figure 11-Photo 1. Tsunami near Sendai Airport (Source, Kawakita Sinposya)

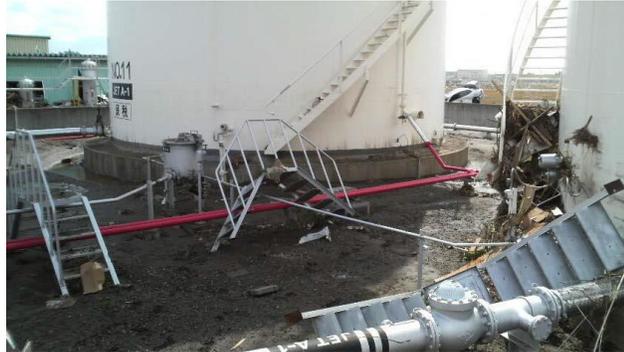
Figure 14-Storage Tank

The tank is installed on a 0.65 meter concrete foundation. It was submerged to a height of 2.4 m from the ground level by the tsunami.

There were a loading rack and other building on the upstream side against the flow of the tsunami. The buildings were able to block the flow of the tsunami, drift materials and debris away. It permitted to prevent it to collide directly with the tank. As a result, the tank was not affected. Also, no major damage was found on other equipment.

At the time of the earthquake, about 80% of the total capacity of the tank was stored. It was about 800 kl of fuel. The buildings close by and the weight of the tanks filled with fuel prevented the tsunami to seriously damage them. In Japan, earthquakes occurs frequently, and for this reason there are strictly prescribed safety standards for buildings against earthquakes according to the Building Standard Law. There were no cracks or deformation of the tank foundation. However, a part of the ground inside the oil proof barrier was vanished by the influence of the strong tsunami flow.

The fuel was withdrawn from the tank and a construction inspection of the tank bottom plate was carried out. Weld repairs were done where we found issues. The degree of damages of the two tanks were minor and repairs were completed in a short period of time.

Storage Tank No.11: Bottom plate ultrasonic inspection was completed on August 23 and bottom plate repair completed on September 28. It included tank cleaning.

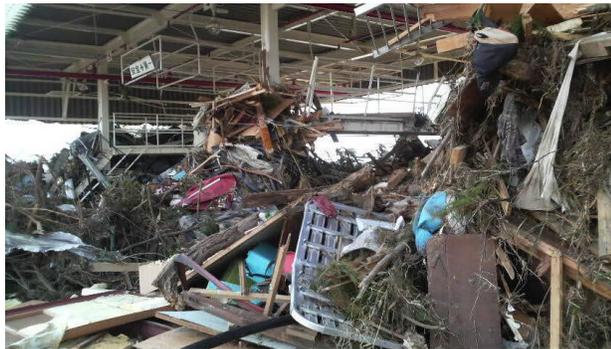
Figure 15-Fuel Loading Facility

There were no serious damages to the fuel receiving bay, but the destruction of the fuel loading bay was enormous. The Tsunami hit the fuel receiving site, all the flowmeters and piping. They were entirely destroyed.

Of course, all hoses and pipes with small diameter were destroyed, and in addition, since seawater flowed from the slop tank and the piped section where it was destroyed, later damage caused by sea water was found in various places.

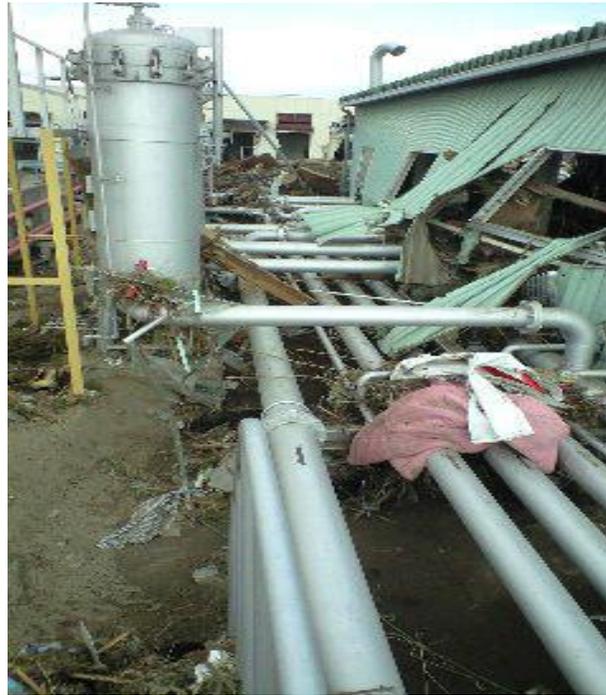
In the filter facility, many of the debris that were being washed away by the tsunami had accumulated but luckily it slightly damaged the pipes and the filter vessel. Due to a building protecting the filter facility, it deviated the direction of the tsunami although some seawater filtrated the drain tank. The foundation was also found damaged.

*Figure 16-Filter Area and Piping*

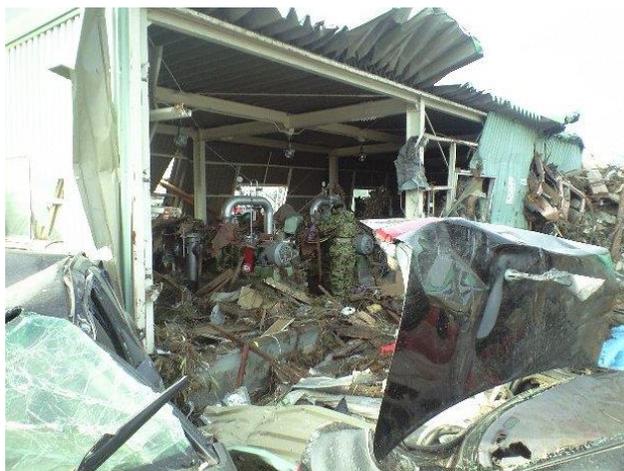
Damages to the fuel transfer pump station and the electric facilities were enormous, and most of the equipment destroyed by the tsunami. Not only had the fuel storage facility fallen but also to the whole area around Sendai Airport, the electrical transmission tower collapsed due to the earthquake. To that end, all of the power transmission had been stopped. Also, auxiliary power equipment and battery facility were lost.

Since the debris caused by the tsunami flowed into the pits for electrical wiring installed in the fuel storage facility, it was urgent to eliminate manually all the debris.

*Figure 17-Fuel Pump Station*

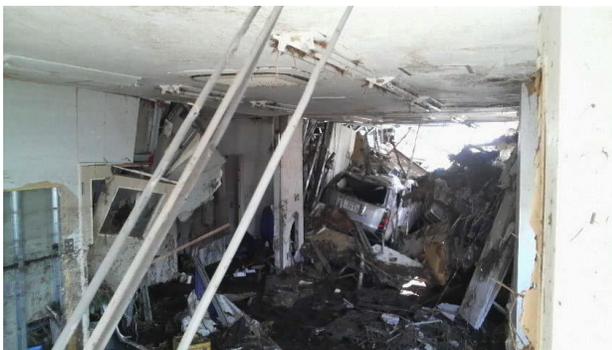
The inside of the building was completely destroyed and lot of drifting matter such as car, rubble and soil due to the tsunami were discovered inside the office building. Many documents drifted with the current making the search extremely difficult. Most of the documents that were discovered were immersed in water and were damaged severely making it difficult to descript. Therefore, the documents necessary for restarting operations were subsequently ordered from the oil companies.

*Figure 18-Inside of Office Building*

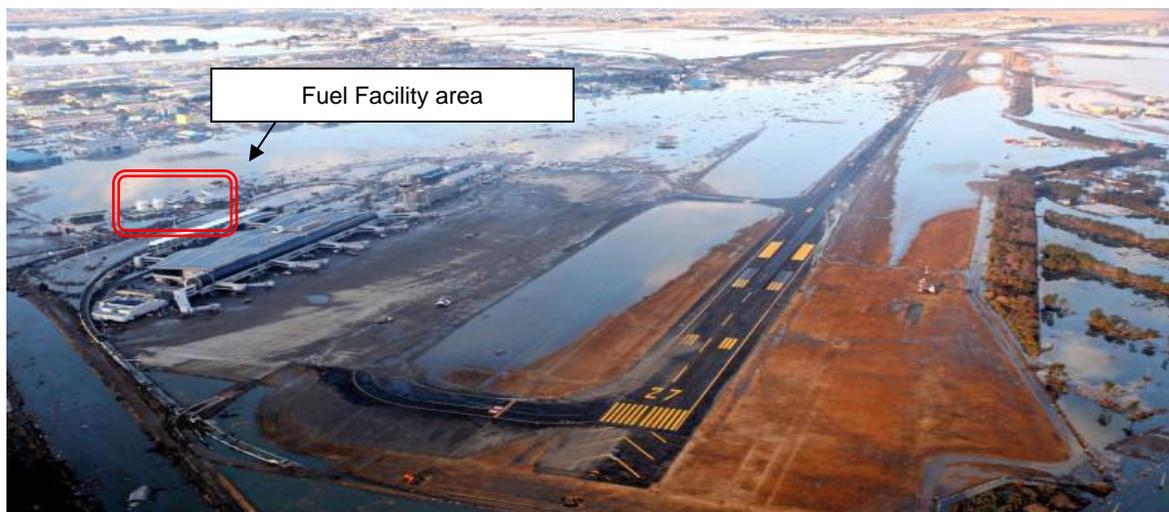
Figure 38-Photo showing flooding by the tsunami at Sendai Airport

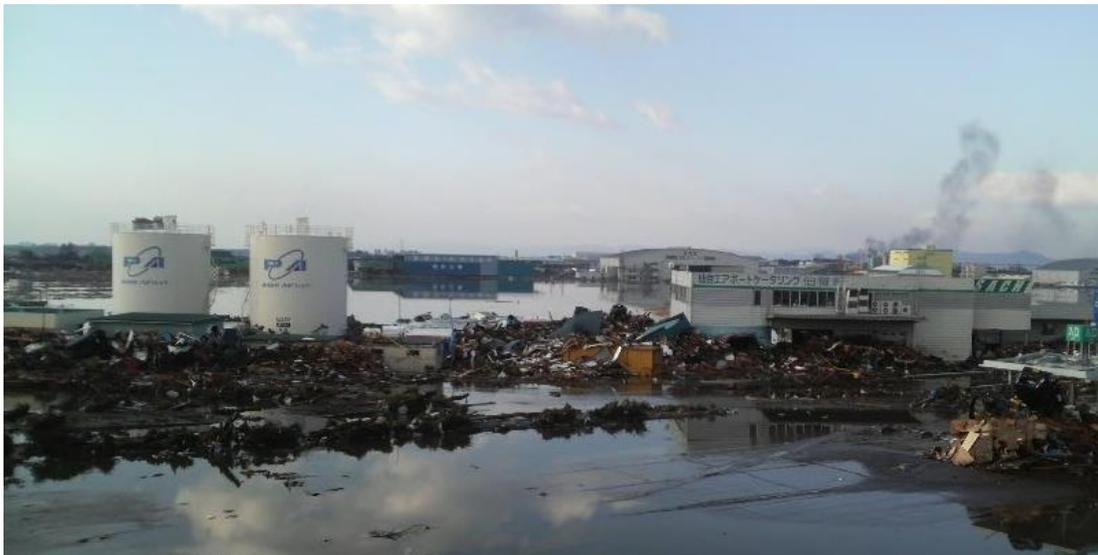
Figure 39-Photo showing huge volume of debris accumulated within fuel facility area

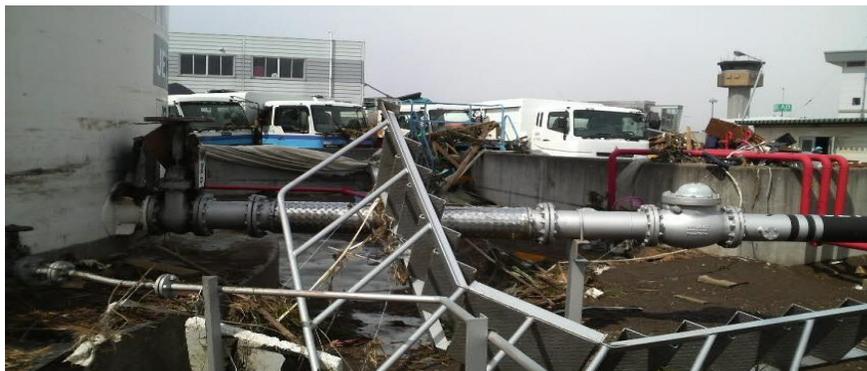
Figure 40-Photo showing less damaged tank and pipe and fell down steps

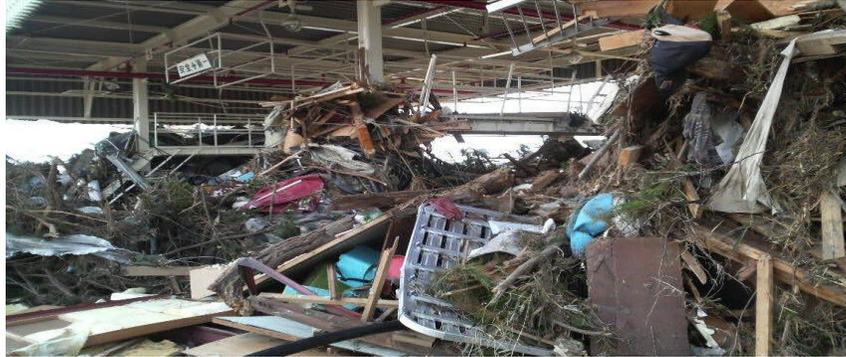
*Figure 41-Photo showing severely damaged and debris accumulated at fuel receiving bay and loading bay*

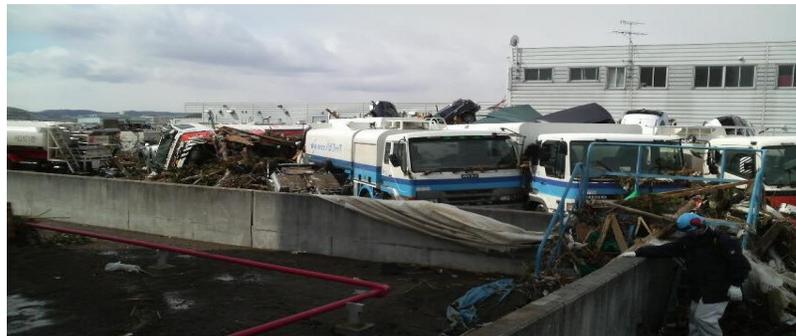
Refuellers were at the apron and in the storage facility. A total of 15 refuellers were damaged and drifted with the flow of the seawater.

*Figure 42-Photo showing damaged fuellers*

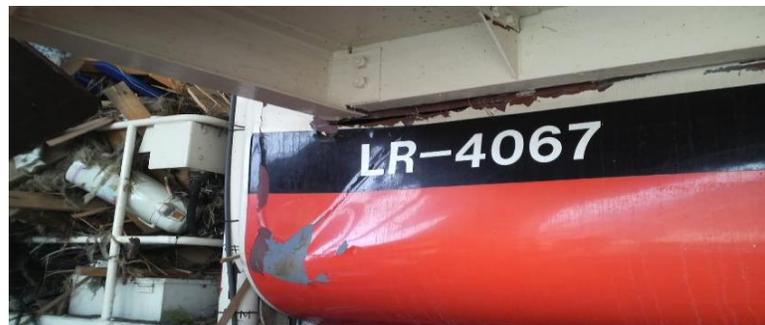
*Figure 43-Photo showing broken tank of the fueller at receiving bay to park.*

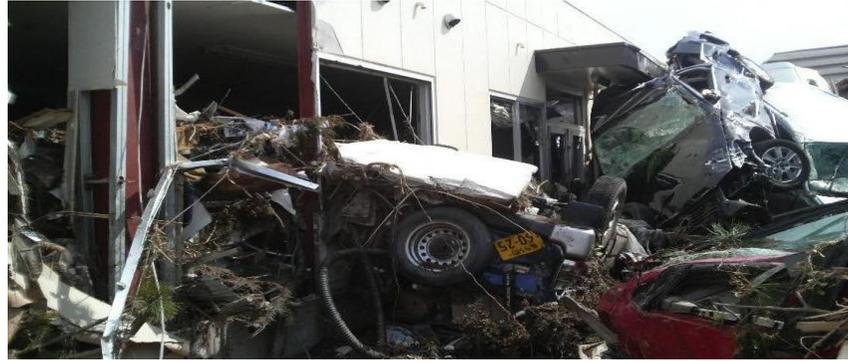
*Figure 44-Photo showing crushed vehicles and debris to the office.*
