# January 2023, Tashkent (TAS) to Almaty (ALA) A321N 5 passengers received minor injuries

SIRM 31 Brussels 2024

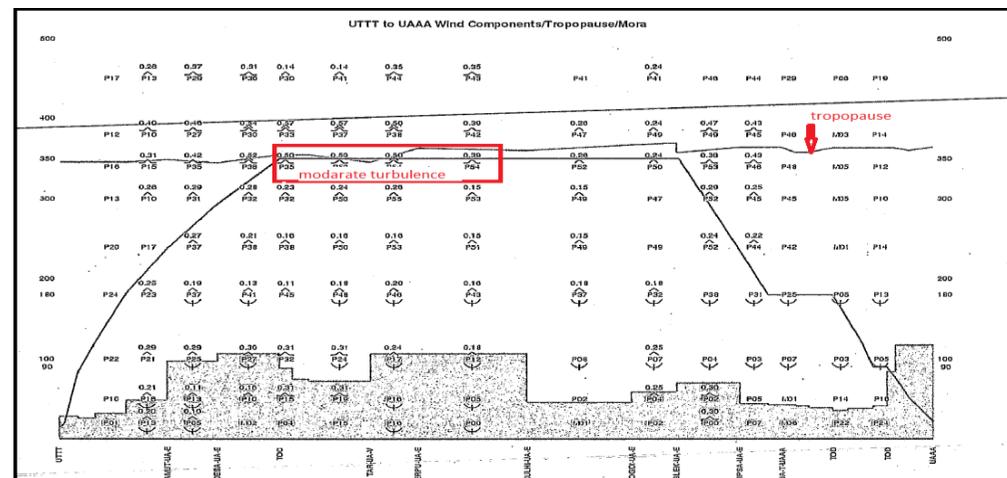
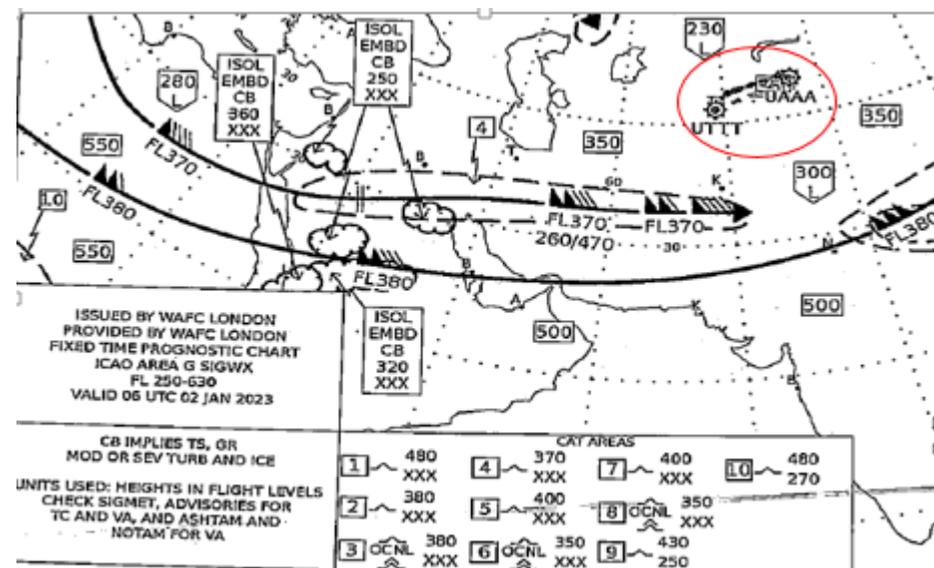
- On pre-flight briefing with flight attendants before the first sector of the flight, the flight crew mentioned the possibility of turbulence activity at cruise level on both flight sectors.
- Flight crew didn't notice any turbulence in flight to TAS at FL340. The crew decided to fly TAS-ALA sector at FL350 in accordance with OFP.
- Significant Prognostic Weather Chart - no significant weather phenomena was observed on the route Tashkent-Almaty.
- Hazardous Weather Chart indicates the tropopause level is crossing FL350.

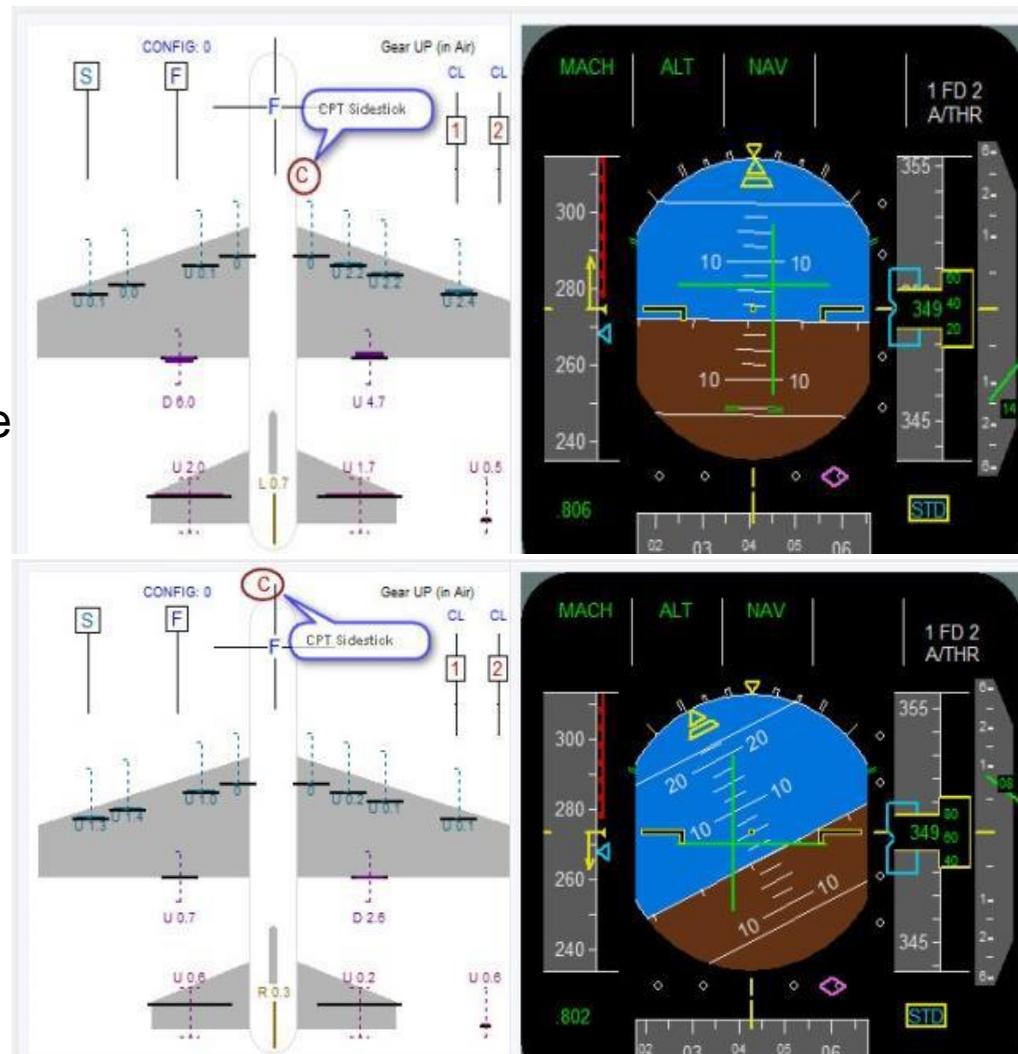
- Flying at FL350 IAS decreased to 245kts (selected speed 266kts) probably due to the wind change. PM announced “SPEED SPEED”.
- Turbulence intensity increased from light to moderate or severe. The IAS started to fluctuate and dynamically increased to 259kts with a speed trending up to 20knots above Mmo and Vertical speed value changes to -1305ft/min.
- PF disengaged the autopilot “instinctively” due to sudden appearance of severe turbulence. QRH PR-ABN-SEVERE TURBULENCE procedure states “Keep auto pilot ON”.

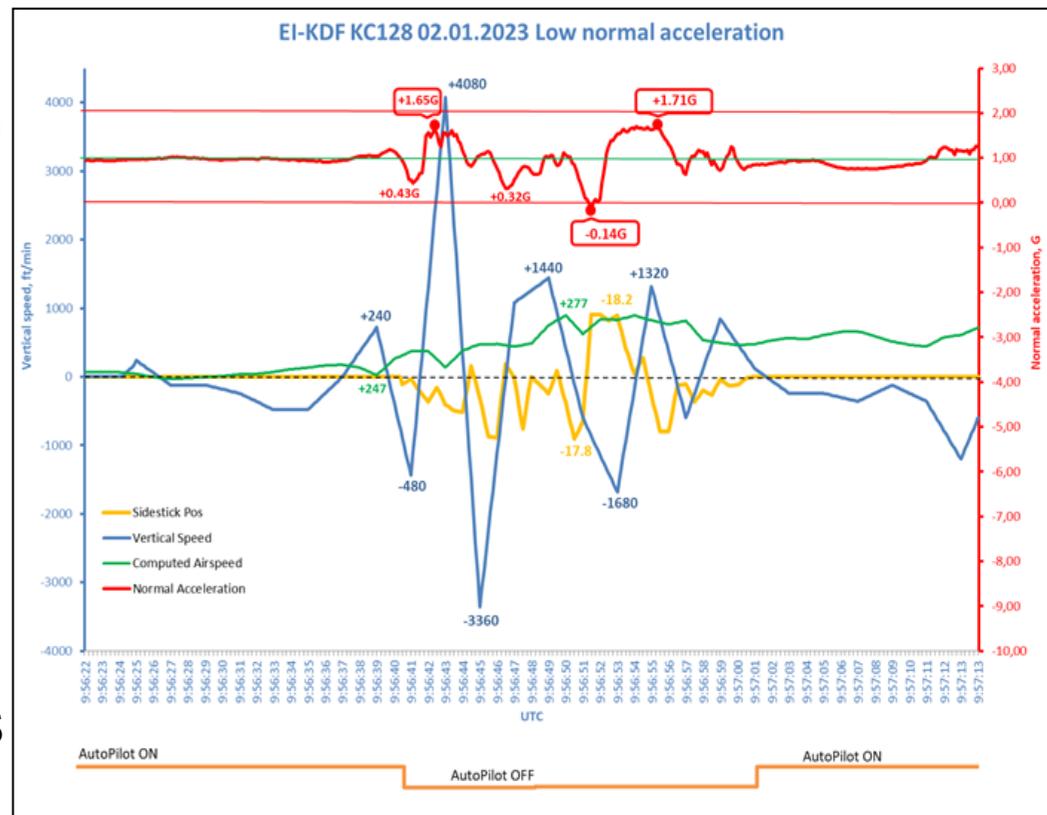
- PF controlled the aircraft manually next 20 seconds. During the manual flight parameters reached next maximum values: right bank angle reached 28.5°, MACH indication reached 0.813, Pitch varied: +10.9/-3.9° vertical speed changed from +4080ft/min to -3360ft/min with full sidestick application ±18.2° units.
- In view of the sudden appearance of severe turbulence and subsequent large changes in IAS and vertical speed, the PF focused more on maintaining IAS in operational limits.

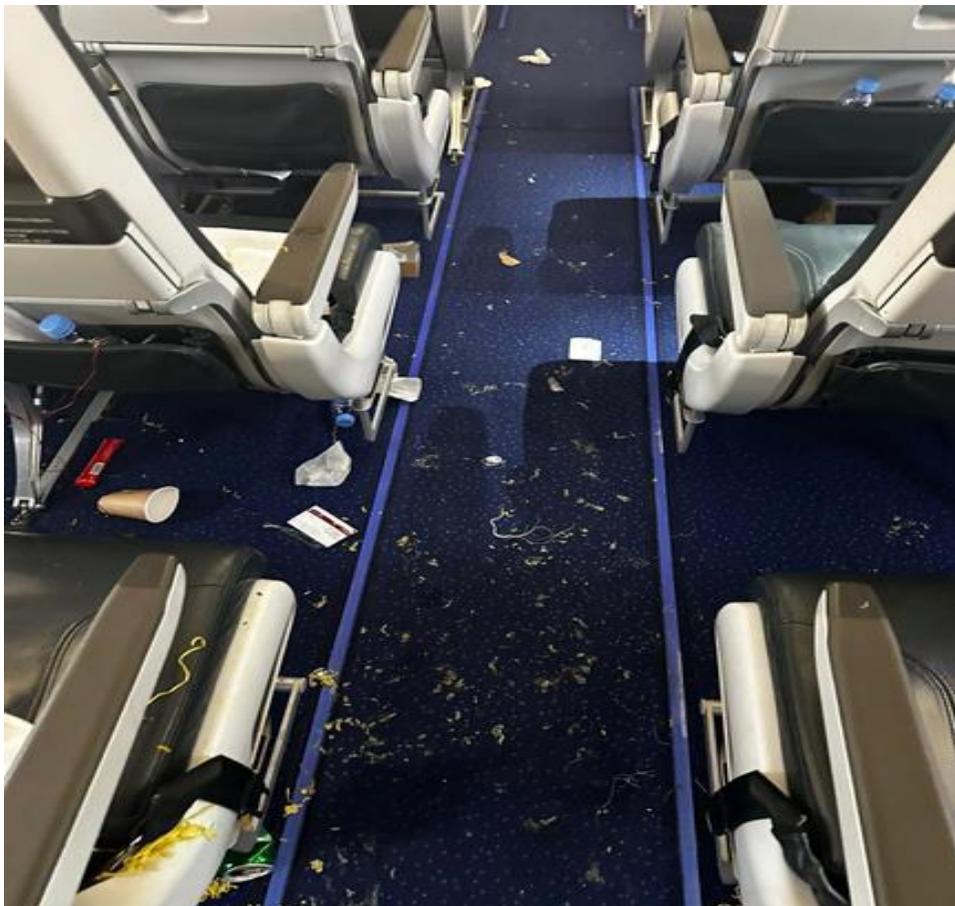
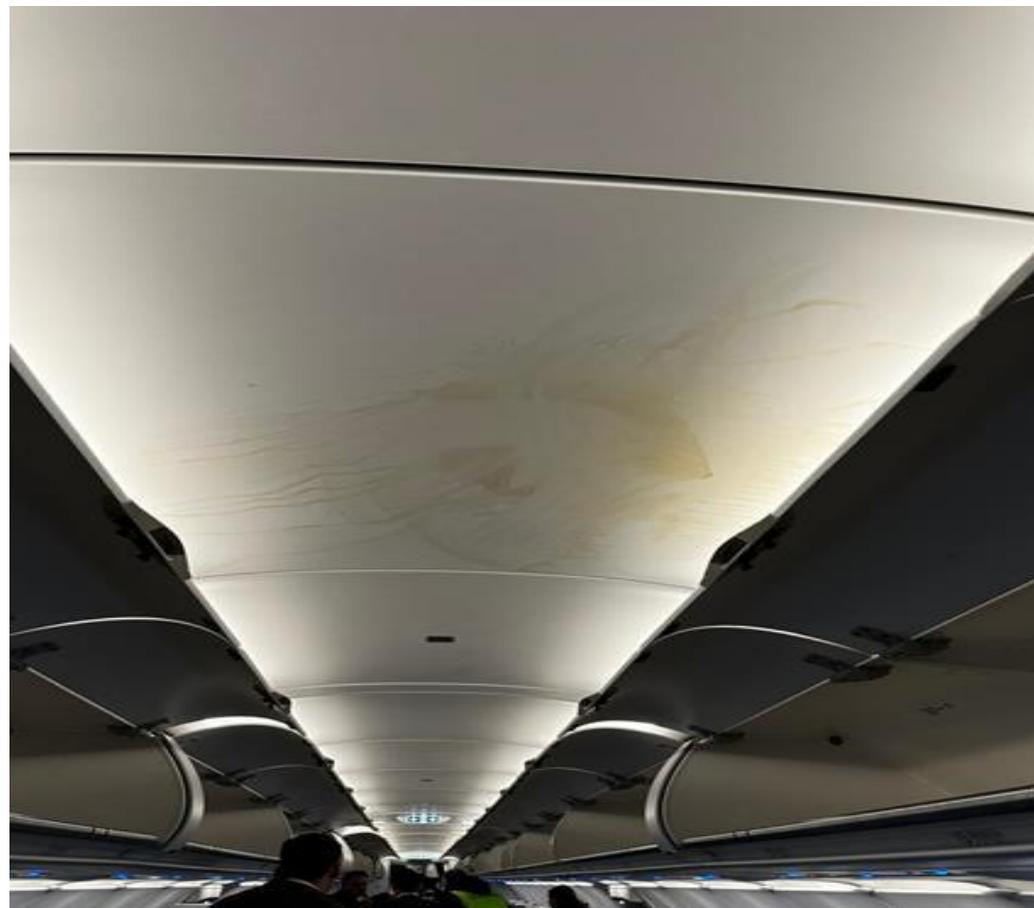
The turbulence started suddenly, the “FASTEN SEAT BELT” sign was switched on and Captain PA command: “Cabin crew be seated”, at the same time a severe vertical acceleration (jump), alike to zero-G state occurred. There were 3 jumps in total, and it lasted for about 20 sec. All CA’s together with the trolleys and equipment flew up to the ceiling vertically. The liquids and foods splashed out to the ceiling, floor and aircraft fuselage.
