2020 - SIRM

Special COVID-19 Bulletin

October 2020

**SAFETY
ISSUE
REVIEW
BULLETIN**

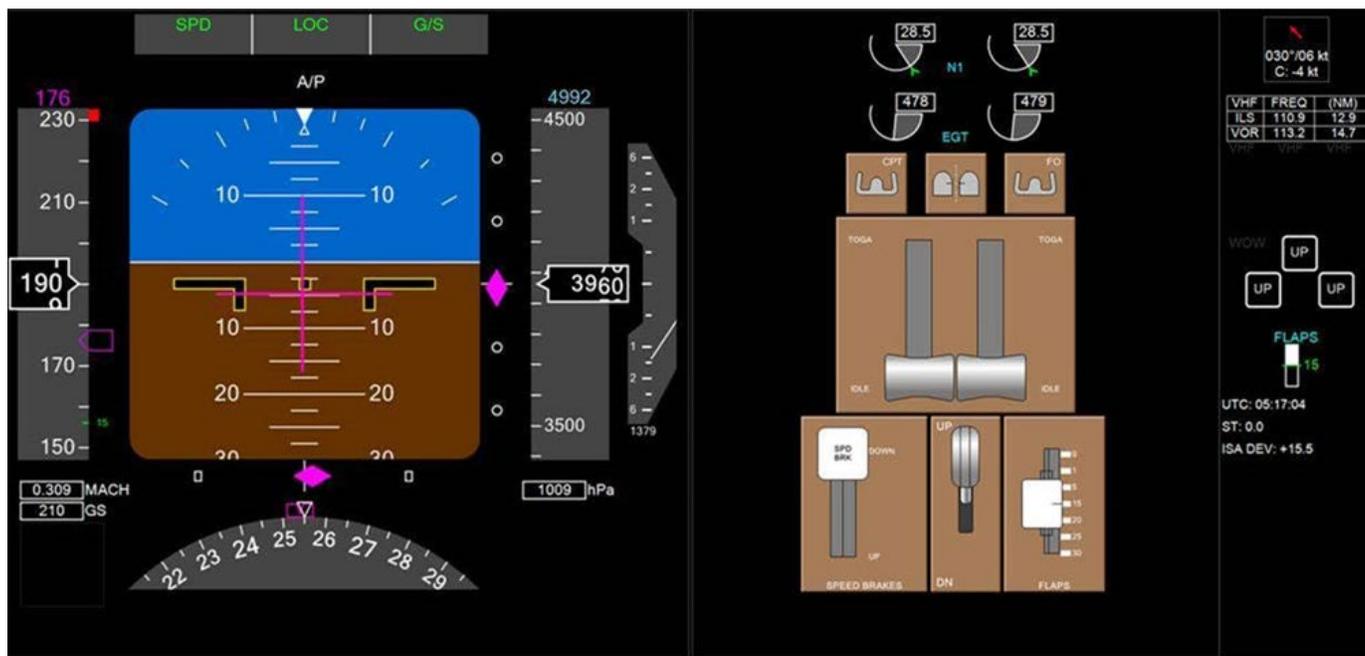
Figure 7 above shows the moment prior to the autopilot disengagement by the PF and the momentary PFD pitch down indication when the altitude versus distance crosscheck was first performed by the flight crew

The QAR data indicated that the ILS signal was valid at the time. Additionally, Hong Kong ATC indicated that the ILS was operating normally and no aircraft or vehicles that could have caused an interference were present in the ILS protected areas.

It is believed that the momentary pitch down attitude and rate of descent was the result of the AFDS correcting a small above glide path deviation caused by an increase in the aircraft indicated airspeed due to a wind shift, and not the AFDS behavior described in the Boeing Bulletin.

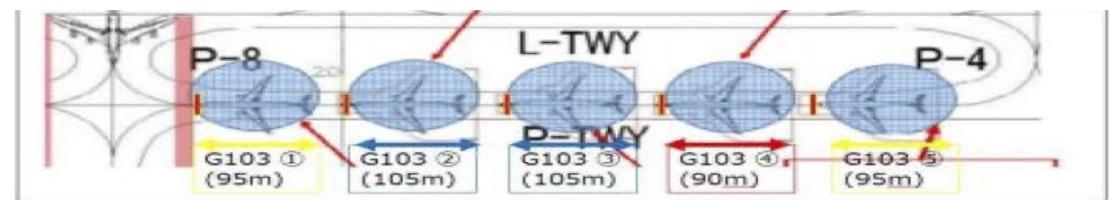
There are five types of aircraft that can be parked on the parallel TWY, as show below. The collided aircraft parking spot was G103 ①.

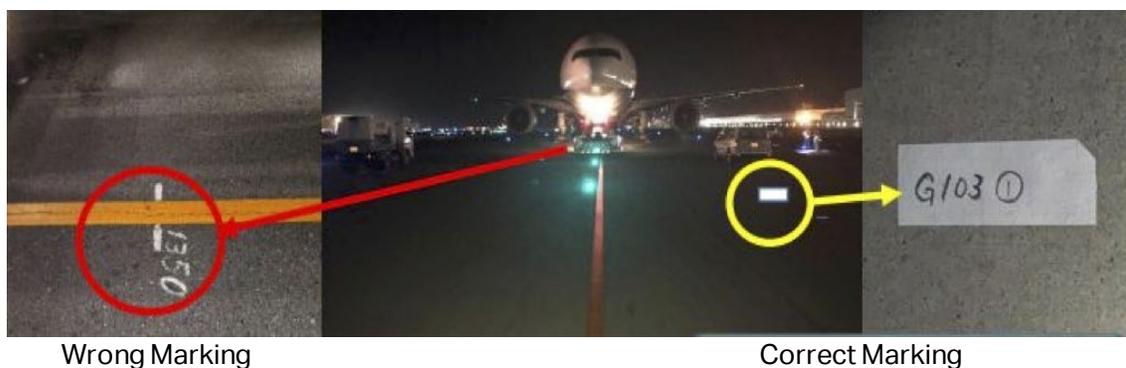
The investigation revealed that the position to identify the correct temporary spot marking was written on a duct tape-like material (because of it's temporary use) at 4.3m away from the TWY center line and not at the edge of the TWY. If it were written on the TWY centerline, the marking could not be seen by the towing operator.

- If the parking of an aircraft is different from the designated area, confirm the parking procedure between the towing operator and the assistant before starting the tow.
- If there is(are) any doubt(s) about the procedures or any concerns, it is strongly recommended to stop the work until the confusion is resolved.
