Operations Notice Number: ON 003/2021

Ninoy Aquino International Airport (MNL), the Philippines

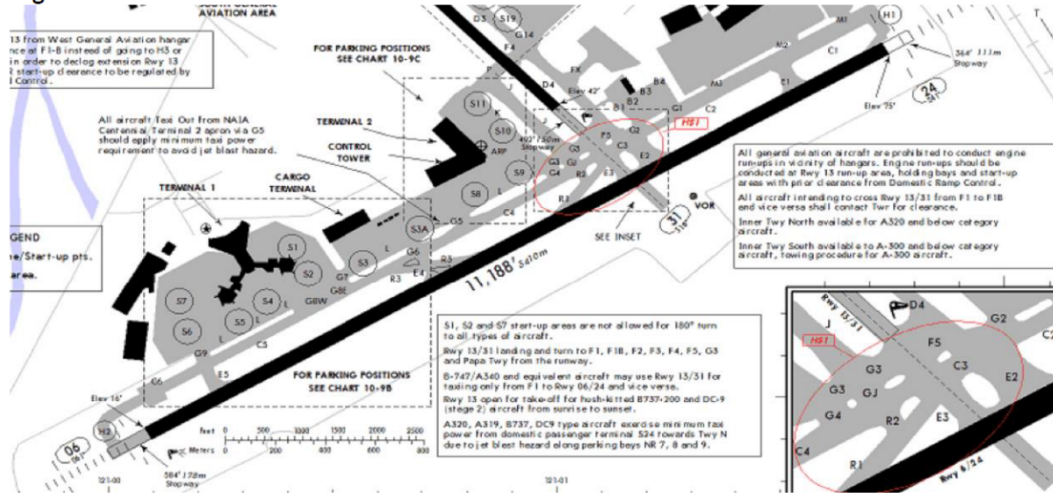
Figure 1:

1. Lack of current aeronautical charts that accurately depict the airfield layout, dimensions and markings
2. Ongoing events of unauthorized illumination of aircraft by laser when operating at MNL airport
3. The intersection of RWY 31 /13 and RWY 06/ 24. This intersection is a known 'hot-spot' area as shown in Figure 1 below. Flight crews have described this hotspot area as:
 - Poorly lit
 - Markings and signage that are non-standard and poorly maintained
 - Confusing due to the complex configuration of taxiways

- Alert flight crews of the existing hazards and potential for runway incursion in the 'Hot-Spot' area and apply appropriate operating procedures to mitigate the associated risks
