# Fuel Operations After Natural Disasters

*Experiences From The Industry*

1st Edition  
Effective 1 February 2018

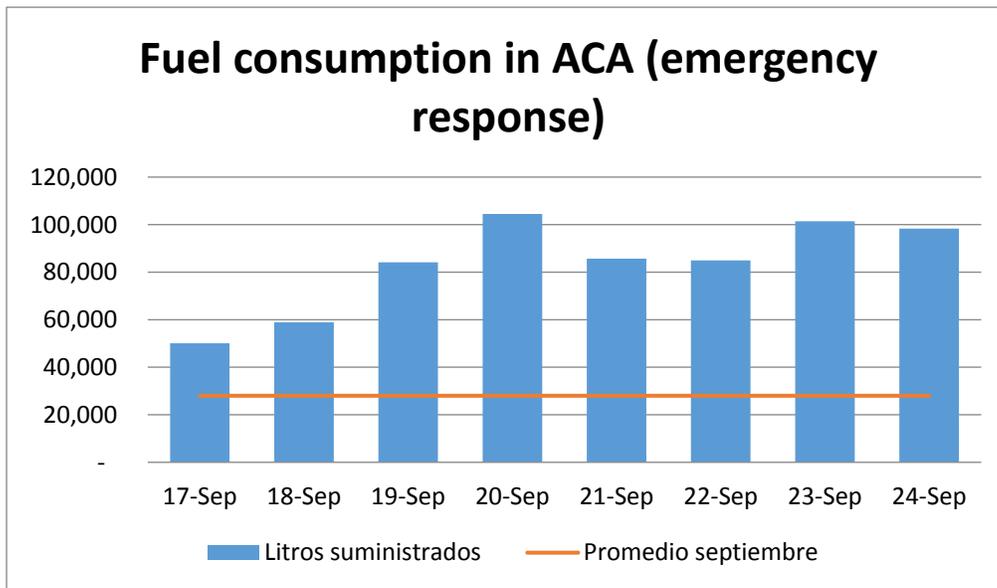
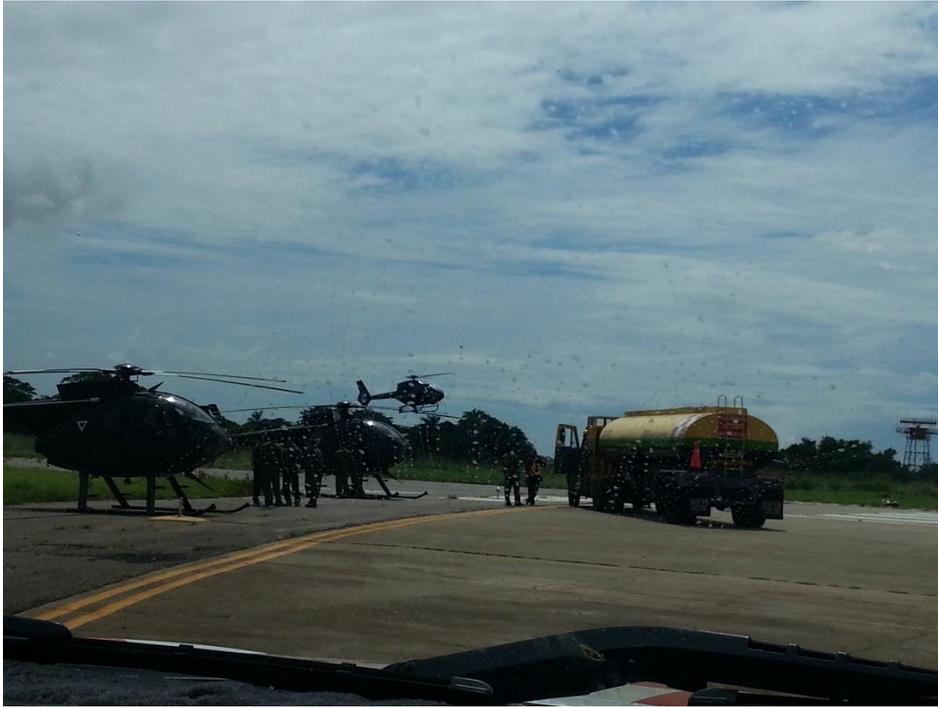
*Figure 7-Fuel supply on September 16, 2013, after the passage of "Manuel" and "Ingrid" Hurricanes at Acapulco Airport, Guerrero*

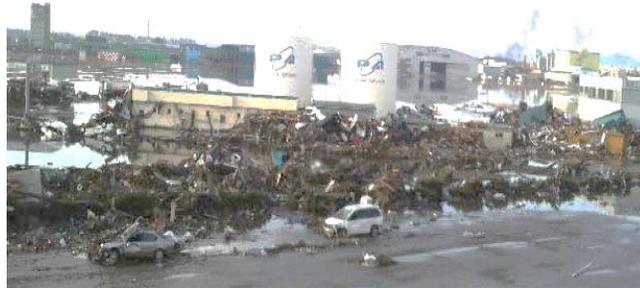
Major facilities that were damaged completely were the storage facility, the pumping station, the fuel loading and unloading, and all the pipes. However, storage tanks had no serious damages and did not float.

Accumulated debris in the fuel facility, due to the tsunami made restoration by human work impossible. Heavy machinery was necessary to remove the heavy materials. Due to the need to restore the lifeline following the earthquake and tsunami, the necessity to quickly restore Sendai Airport has made it possible with the help of

the US military. They were a major contributor of the restoration of the fuel facilities. The US military introduced heavy machinery and quickly removed debris in the fuel facility. However, what was left of the office building was clogged with tsunami drifting objects, and these were forced to be removed manually.

Figure 13-Photo 2. Sendai Airport Fuel Facility after Tsunami

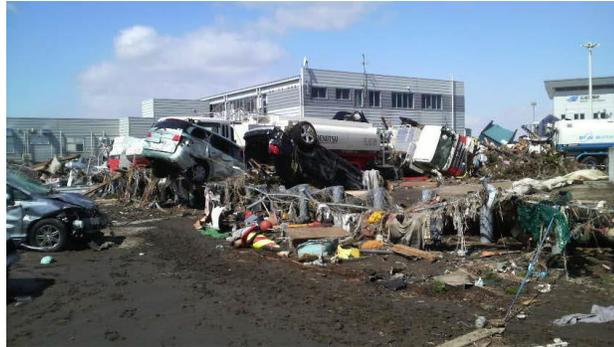
*Figure 19-Motor Pool*

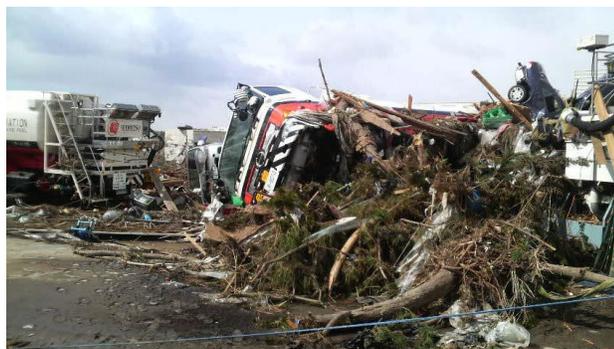
After the earthquake, the powerful tsunami reached Sendai airport rapidly and made it impossible to evacuate the refueller into a safety zone.

All the refuellers were considered scrapped because they were soaked in the seawater, due to the tsunami. The fuel left in the tank of the refueller passed a fuel quality test. The fuel which could be confirmed with no contamination could be used again. The fuel tested at the refinery laboratory was in accordance with the joint checklist.

*Figure 20-Refuellers*

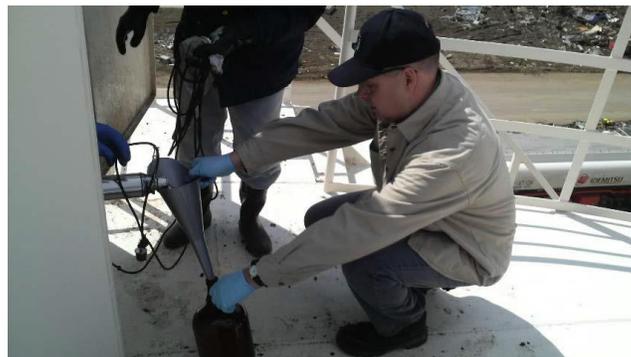
*Figure 21-Fuel Sampling from Storage Tank by US Military*

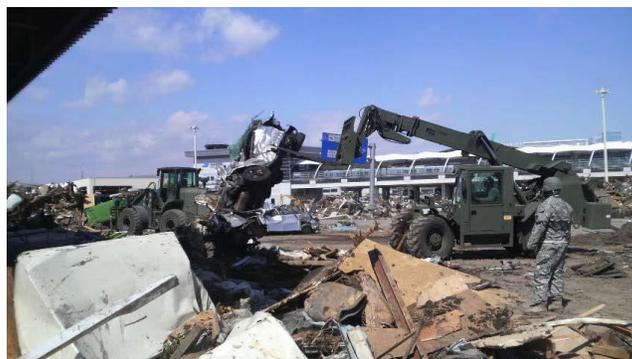
*Figure 22- Restoration Work by Japanese Defence*

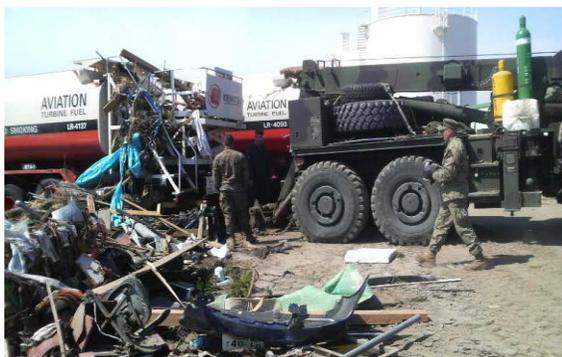
Figure 23-Restoration Work by US Military

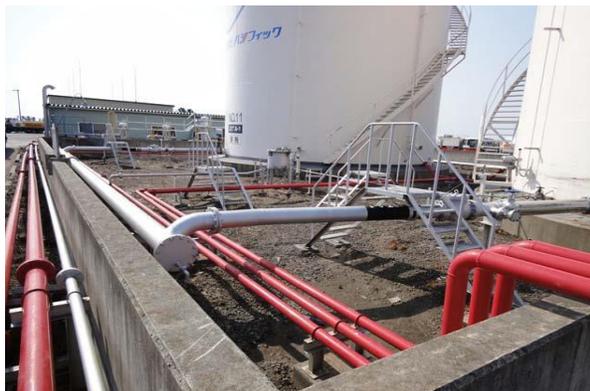
The tank is installed on a 0.65 meter concrete foundation. It was submerged to a height of 2.4 m from the ground level by the tsunami.

The fuel was withdrawn from the tank and a construction inspection of the tank bottom plate was carried out. Weld repairs were done where we found issues. The degree of damages of the two tanks were minor and repairs were completed in a short period of time.

Figure 25- Fuel Storage Tank after Restoration Work

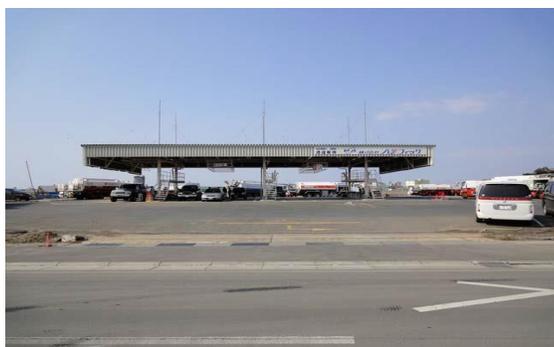
There were no serious damages to the fuel receiving bay, but the destruction of the fuel loading bay was enormous. The Tsunami hit the fuel receiving site, all the flowmeters and piping. They were entirely destroyed.

Figure 24-Fuel Loading Station after Restoration Work

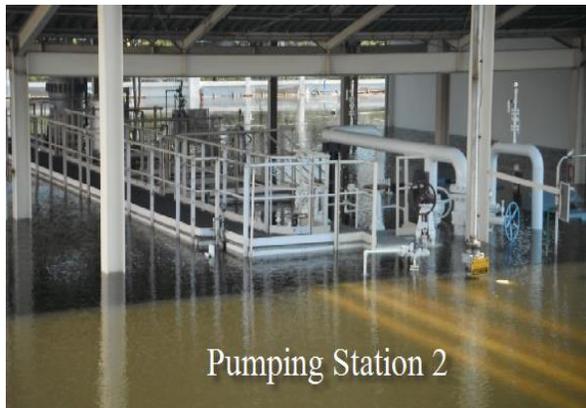
Pumping Station 2

In the night of 31 October 2011, the flood water from Premprachakorn canal breached the western perimeter fence, causing a 30-meter section of the fence to collapse, and rapidly covering the depot under 1.5 meter of flood water.

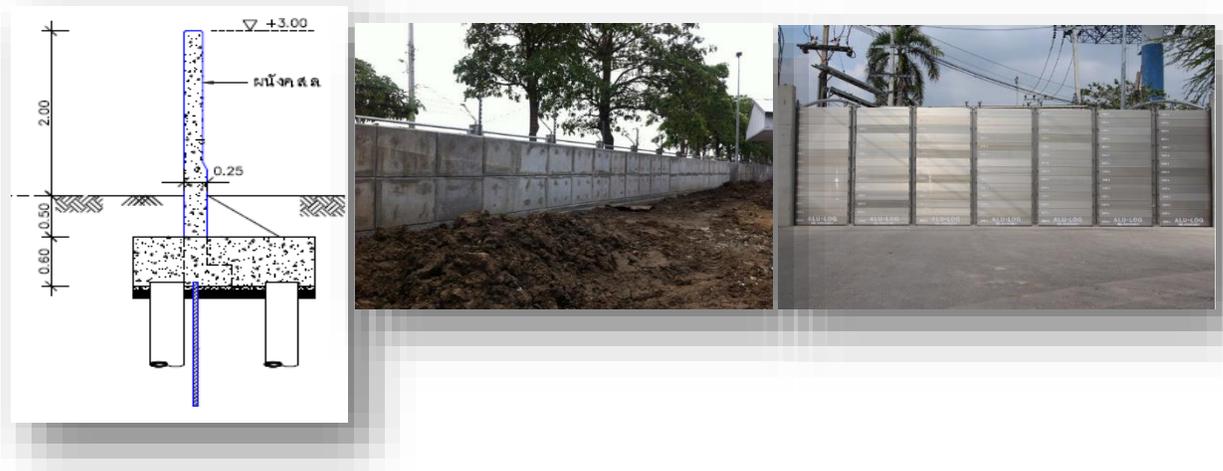
However, BAFS-BKK depot was an unaffected area in 2011 but we had experience and implemented the lessons learned from DMK. The company has decided to make a permanent flood protection as follows:

- To construct concrete fence of a height of +3.00 MSL and an underground concrete sheet pile depth -2.00 MSL to protected flood water leaks.
- To provide mobile flood protection door (stop log type).
- To install two new drain gates for storm water drainage.

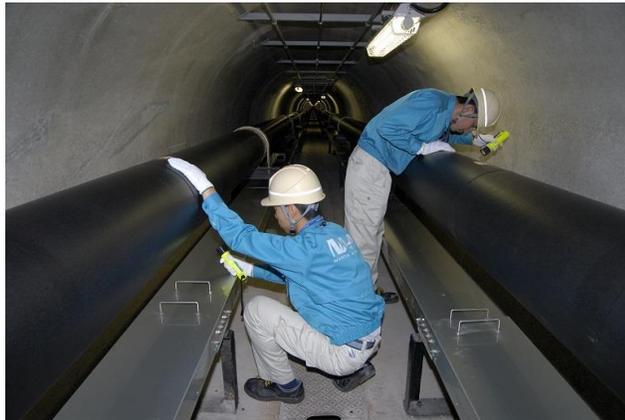
*Figure 33-Visual Inspection for Pipeline in the Tunnel Area*

In this case, accomplish external inspection for major part of pipeline and pressure decay rate check carried out when pipeline operation is stopped.

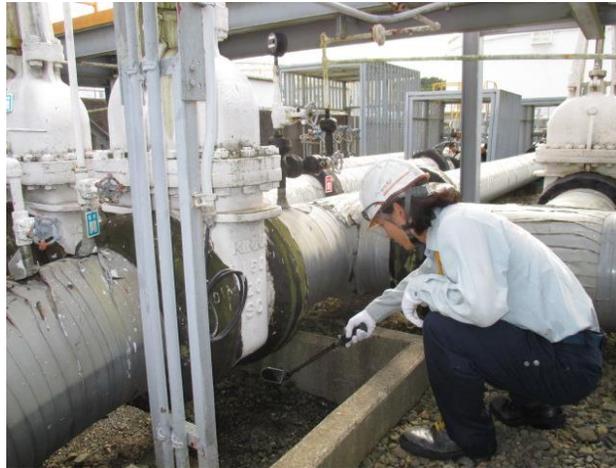
*Figure 34-Visual Inspection for Joint Area in the Storage Facility*

Visual check for outline and leakage of the storage equipment and pipeline.

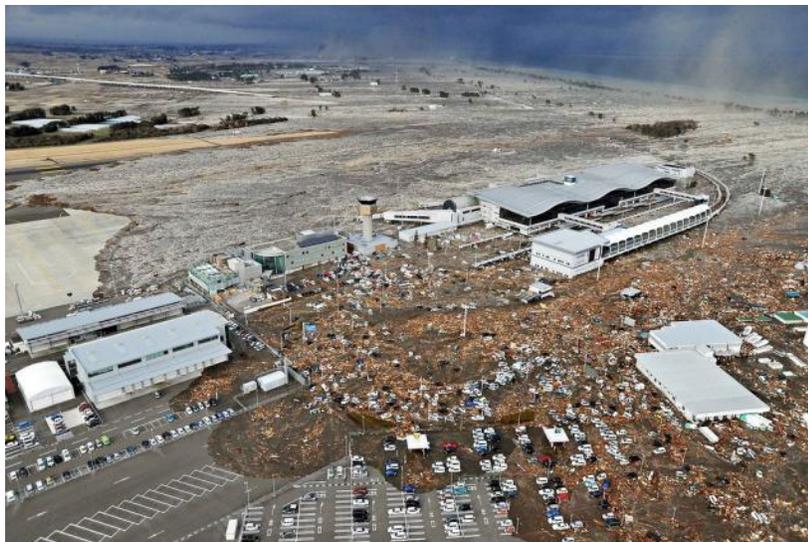
*Figure 37-Photo showing Tsunami spreading at Sendai Airport*

The runway was closed soon after the earthquake occurred, and approximately 1,400 people of passengers, surrounding residents and staffs were evacuated in the Terminal building. At 15:56 JST on March 11, 2011, airport and related facilities were flooded by the tsunami. The Sendai airport terminal building was severely damaged and stopped all airport operations. The terminal building was flooded to a height of 3.02 m and lots of cars, debris flowed into the first floor of the terminal building. No airlines aircraft parked on apron at this moment but 67 general aviation aircrafts and helicopters were damaged by the tsunami.

US military (Tomodachi-campaign) had a great contribution to clean-up runway and disposing of debris and damaged cars etc. in the early stage of the recovery.
