# January 2023, Tashkent (TAS) to Almaty (ALA) A321N 5 passengers received minor injuries

SIRM 31 Brussels 2024

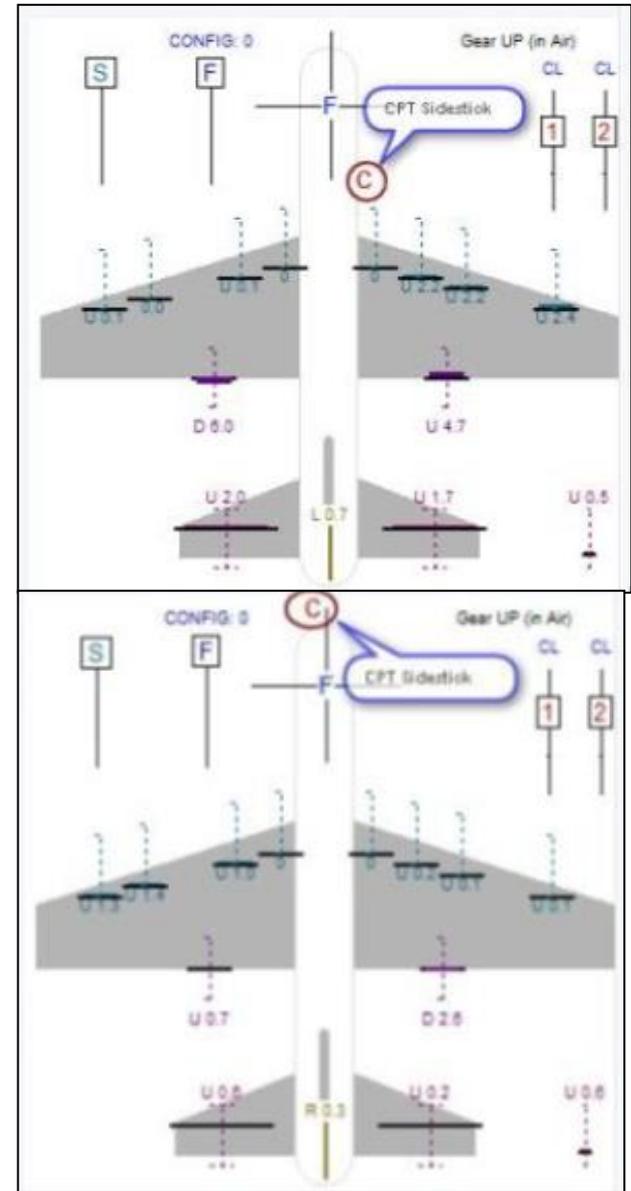
# Why it happened?

- Poor analysis of Hazardous Weather chart
- Switching to manual control of aircraft in contradiction with Airbus QRH PR-ABN-SEVERE TURBULENCE procedure
- While manual flying PF was chasing the vertical speed changes instead of keeping pitch in recommended limits 2-5 degrees
- Disengagement of AP resulted in increasing PF workload as a result reduced capacity to manage pitch attitude
