2020 - SIRM

Special COVID-19 Bulletin

October 2020

**SAFETY
ISSUE
REVIEW
BULLETIN**

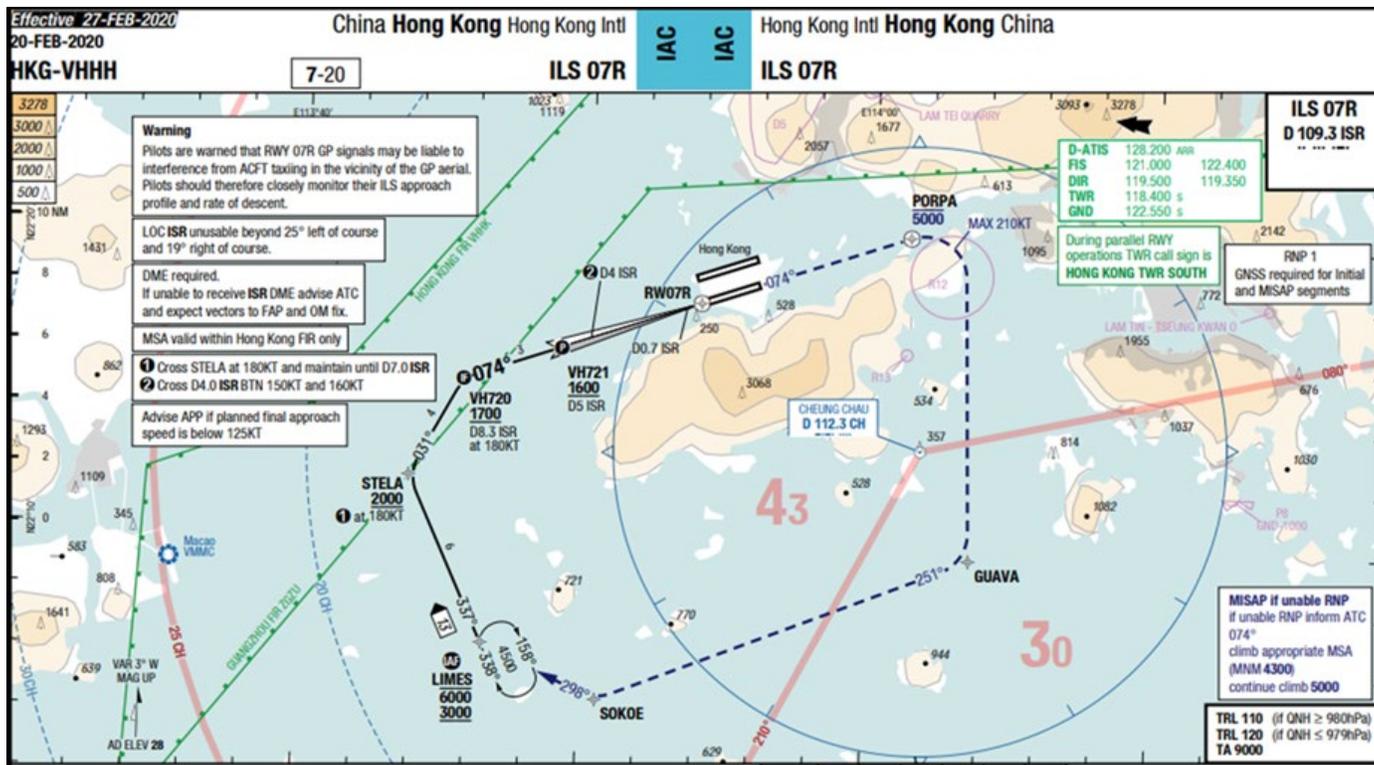
A false glideslope capture on the ILS approach to runway 07R, resulted in an early descent below the ATC cleared altitude and the minimum procedure altitude prior to the FAP. The Approach (APP) mode was disengaged at 1,700 feet QNH, and the descent continued in Vertical Speed mode until the aircraft levelled off at 1,100 feet QNH. The ILS was recaptured at 3.9NM ILS and stabilization criteria was achieved at 1,000 feet aal. The approach was conducted in night VMC weather conditions.

The flight was initially cleared for the ILS approach to runway 07L which is not associated with potential ILS signal interference due to the location of the antennas. Prior to commencing the approach, ATC re-cleared the flight for an ILS on runway 07R.

The flight crew was aware of the hazards and possible threats of ILS signal interference during approaches to runway 07R. However, due to the late change of runway, there was no update to the approach briefing to discuss ILS interference mitigation strategies.

The possible root cause for the ILS signal interference was a Boeing 757 that was holding at the runway 07R CAT I holding point at taxiway K1.

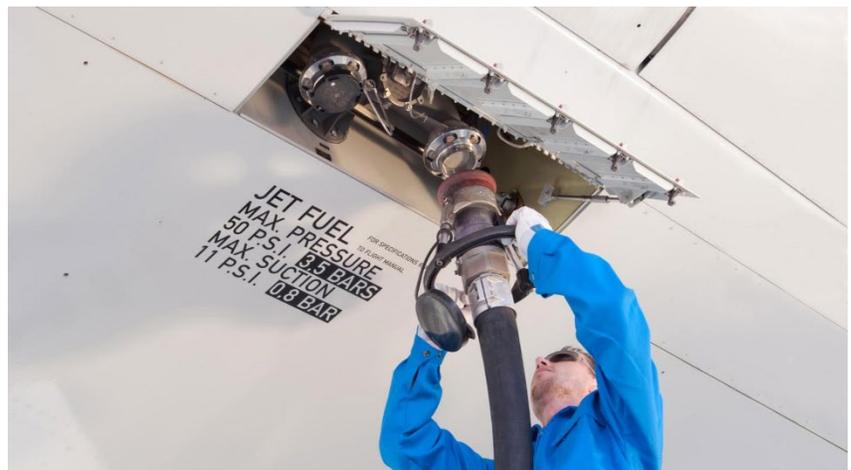
Prevention is better than a cure, microbiological contamination requires a combination of three factors - microbes, fuel and water. Since the presence of the microbes cannot be eliminated, and fuel is required in the tanks when storing the aircraft, in order to prevent fuel contamination the action is to remove the water. This can be done by regular water drainage.

Whilst a scheduled water drainage task is likely to be included in the parking/storage procedures, operators should assess and adjust this accordingly. It may be that the drainage interval for normal operations may no longer be adequate, and as a consequence the interval should be reviewed and if necessary reduced. Regular water drainage and also fuel contamination checks can help avoid an expensive problem before it occurs.

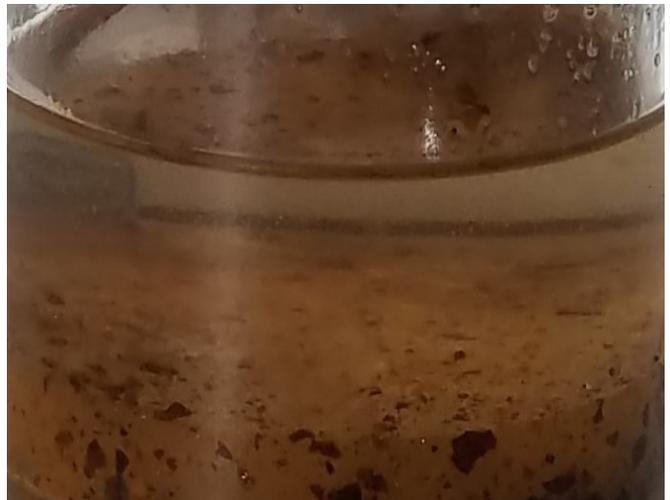
Figure 1 - 30-day old untreated fuel sample

Microbiological contamination begins the moment fuel leaves the refinery and continues to accumulate through the supply chain to its final destination. Microbes need water and food to survive and multiply. The consensus is, keep fuel dry and you reduce the chance of biodeterioration. However, that is easier said than done. Water is always present in fuel at some level and it doesn't take much to sustain life. Fuel systems are constantly breathing, bringing in more contaminants including additional microbes and water in the form of condensation. A single drop of water can sustain colonies of microbes. As condensation forms, free water accumulates exacerbating the problem of microbial contamination. Long-term storage magnifies all of the problems linked to biodeterioration.

Fuel is a food source. Microbes consume fuel, breaking down the hydrocarbons and producing corrosive acids. They also change the composition of the fuel as they metabolize it. Microbes multiply at high rates and typically live in consortia. Never found alone, different species establish symbiotic relationships beneficial to each other forming biomass environments at water-fuel interfaces (Figure 1) on tank walls and linings or most any place in a fuel system capable of concealing a tiny fraction of water.
