Safety Report 2001

Issued March 2002

International Air Transport Association

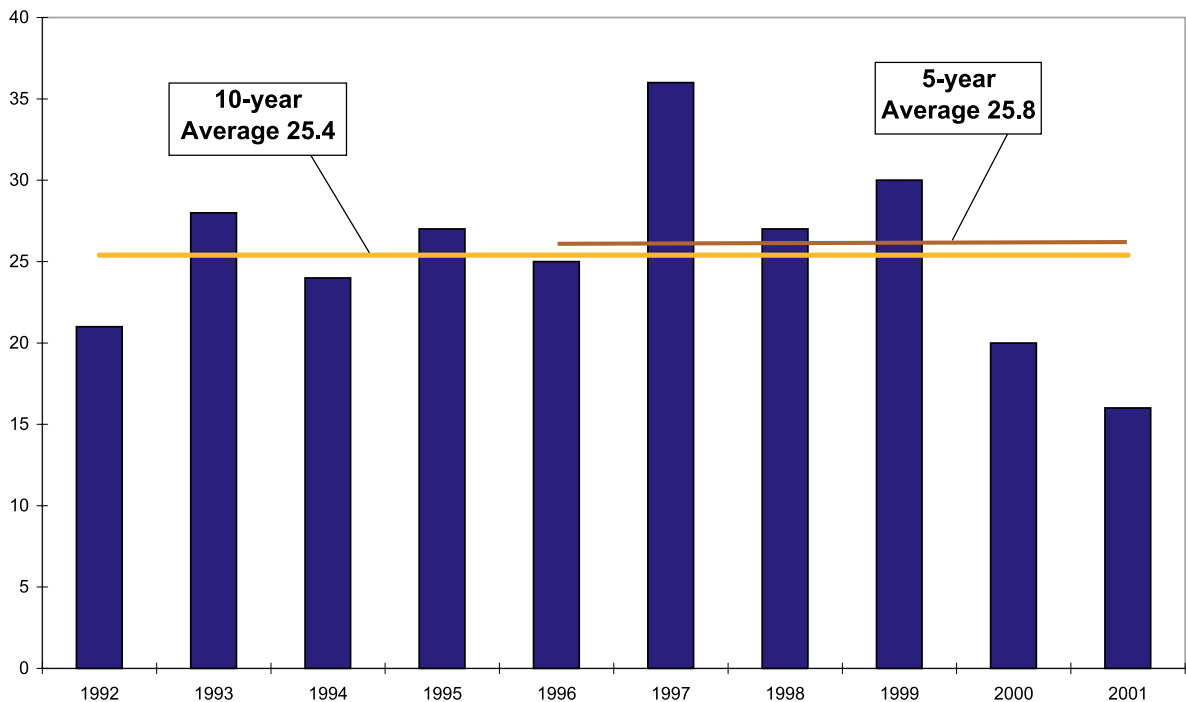
Figure 3.1.E
Operational Hull Losses (1992-2001)

The following graphs depicts the operational Hull Losses and the 5 and 10 year averages for the 1992 -2001 period.

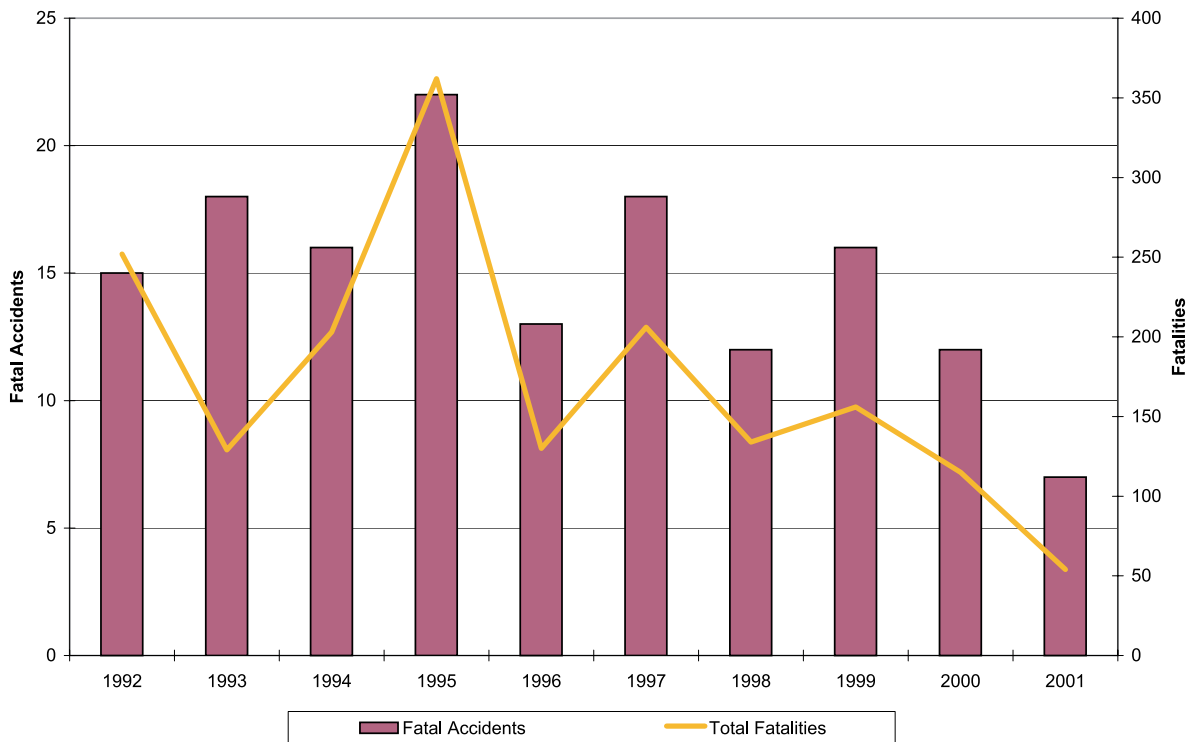
Figure 3.1.H
Fatal Accidents and Fatalities (1992-2001)

Fatal Accidents: 149
 Passengers on board fatal flights: 2,139
 Crew on board fatal flights: 420
Total on Board: 2,559

% Passenger fatalities vs passengers on board: 66%
 % Crew fatalities vs crew on board: 79%

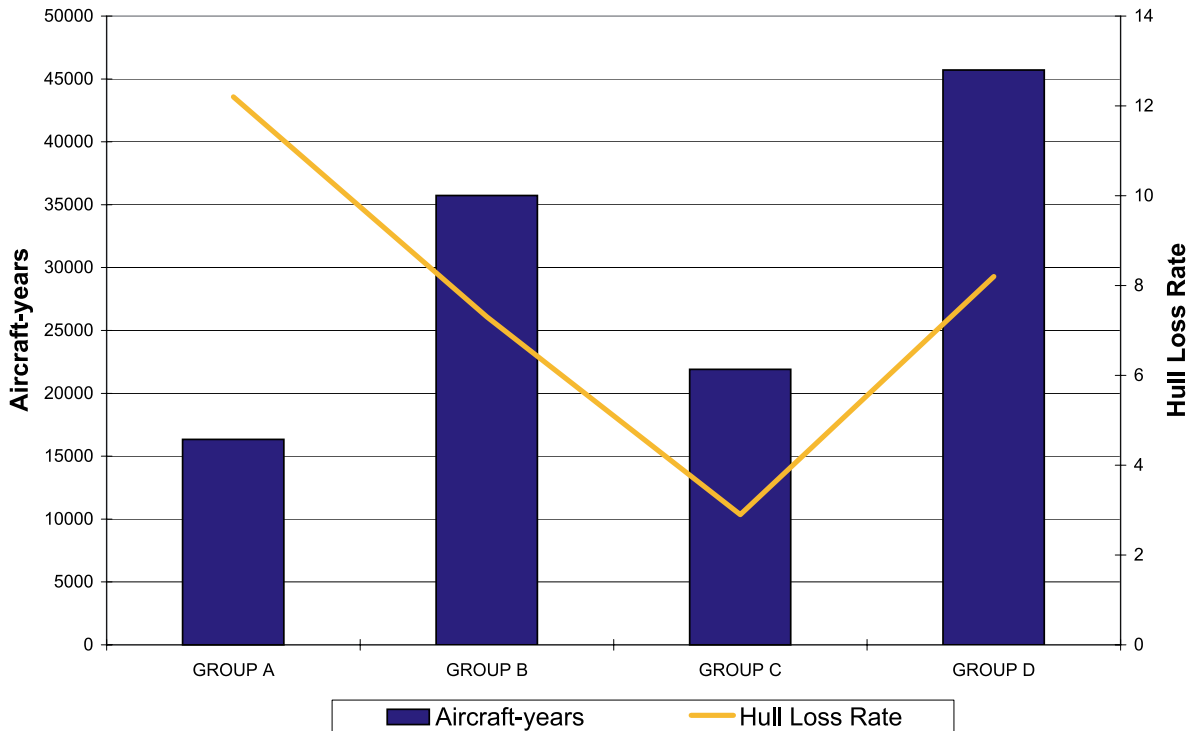
**Figure 3.1.K
Loss Rate and Exposure (1950-2001)**

Since entry into service, Turboprop aircraft have accumulated 119,616 aircraft years and have suffered 902 operational Hull Loss accidents. This gives an average Hull Loss rate for the period of 7.54 per 1000 aircraft years. The Figure 3.1.K shows the aircraft years flown by each aircraft group and the corresponding Hull Loss rate. Refer to Appendix C for definitions of aircraft groups.

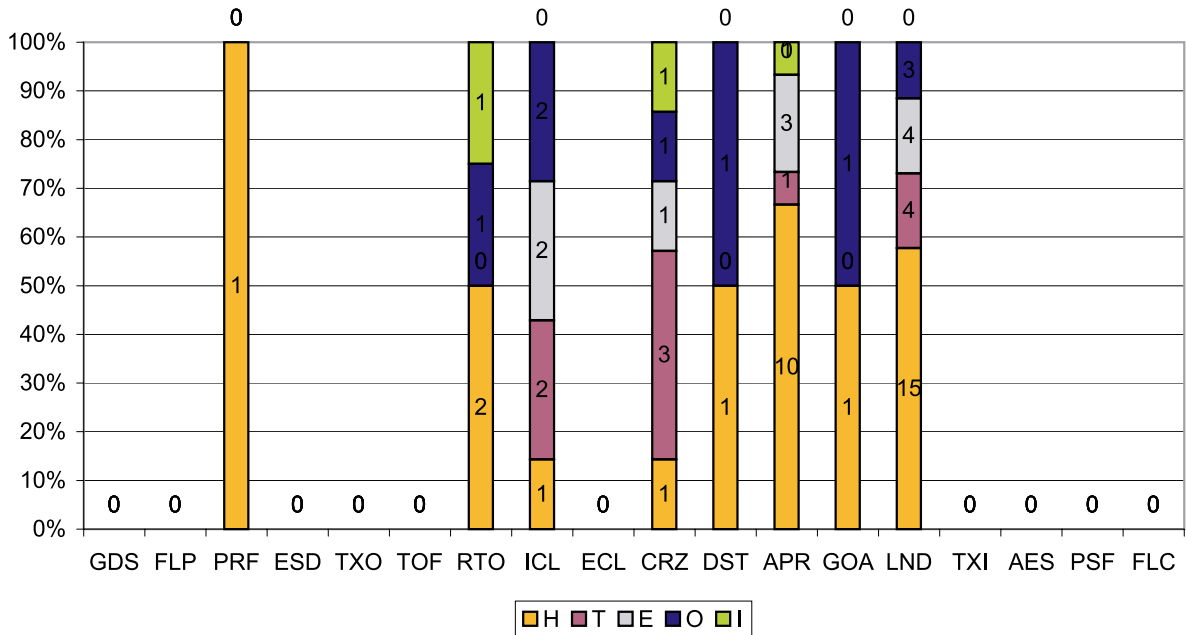
Figure 3.2.G
Contributing Factors by Phase of Flight

The graph and table below show the contributory factors by phase of flight. The approach and landing phases of flight are significant in that 78% of all Human Factors, and more specifically 78% of the skill failures (H3) and 75% of the weather related (E1) accidents occur during this stage.

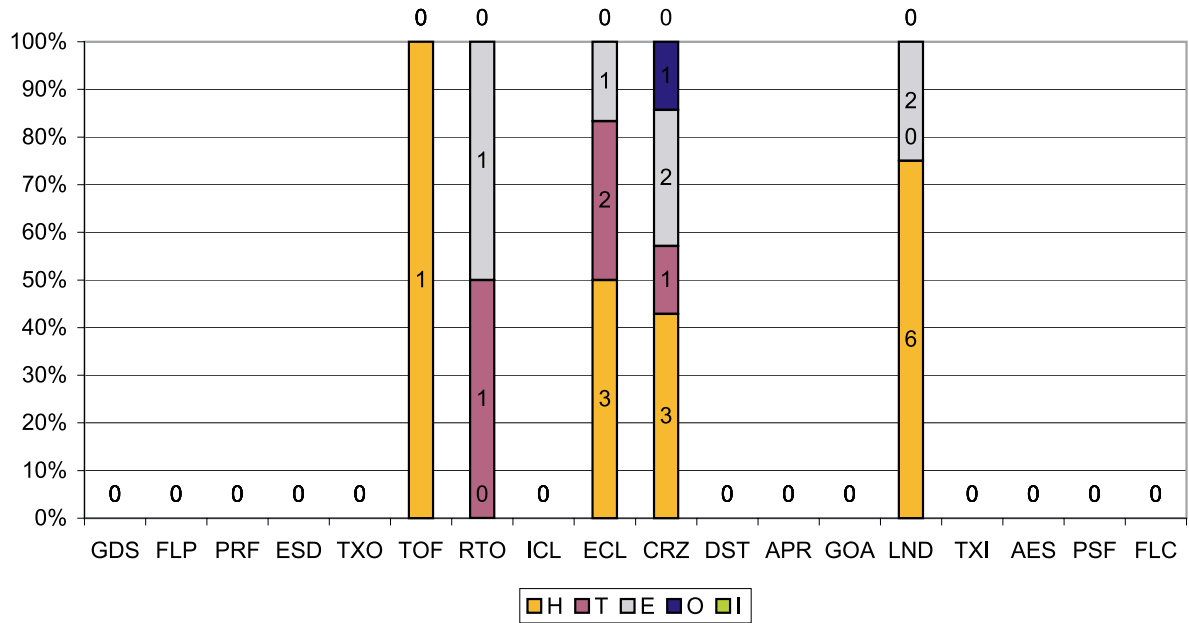
Figure 3.4.G
Contributory Factors by Phase of Flight

The next greatest contributing influences were Environmental Factors, with weather (E1) accounting for 5 cases in this category, which is 39% of all Eastern Built Turboprop accidents. Of the 13 accidents, 3 are known to have happened in darkness.

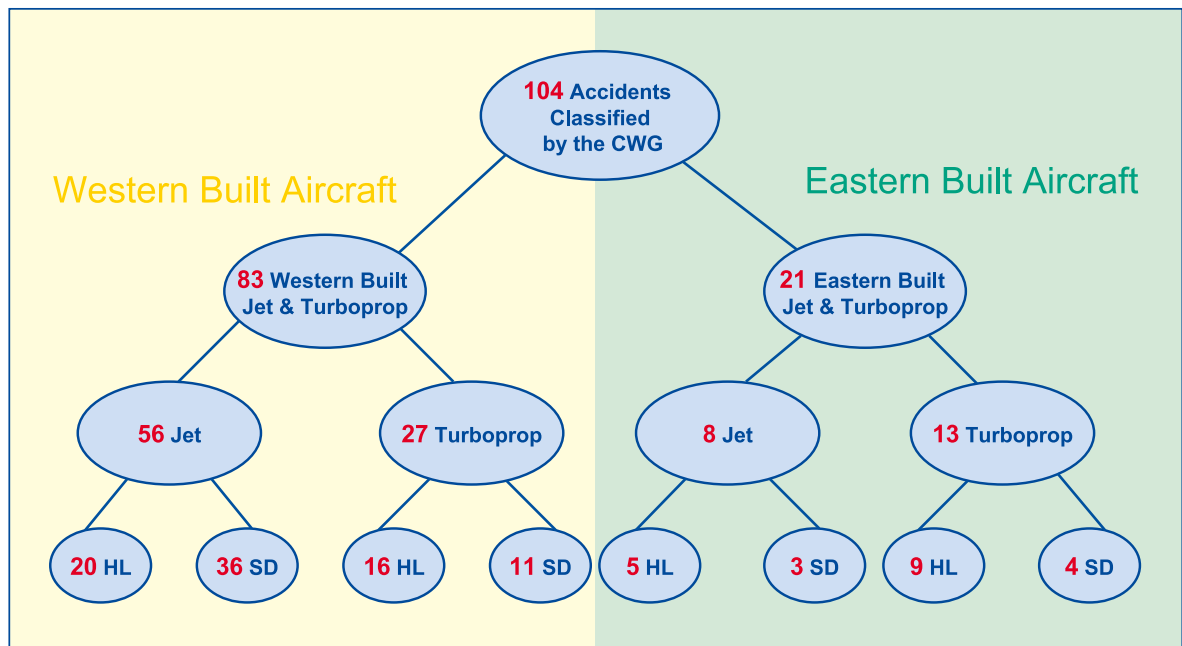
Figure 4.1.C
Distribution of 2001 Accidents

The CWG Classified 104 accidents involving Western and Eastern Built Jet and Turboprop categories distributed as shown in Figure 4.1.C. These are the **Operational** Jet and Turboprop Hull Loss (HL) and Substantial Damage (SD) accidents that occurred in 2001 and are the primary focus of the Safety Report. Throughout this analysis it should be assumed that only operational accidents are being addressed unless specifically stated otherwise. An operational accident is one which occurred during normal revenue operations or positioning flights. This chart therefore **excludes** ground events where there was no intention of flight and **deliberate acts of violence such as the 4 aircraft involved in the 11 September 2001 terrorist attacks.**

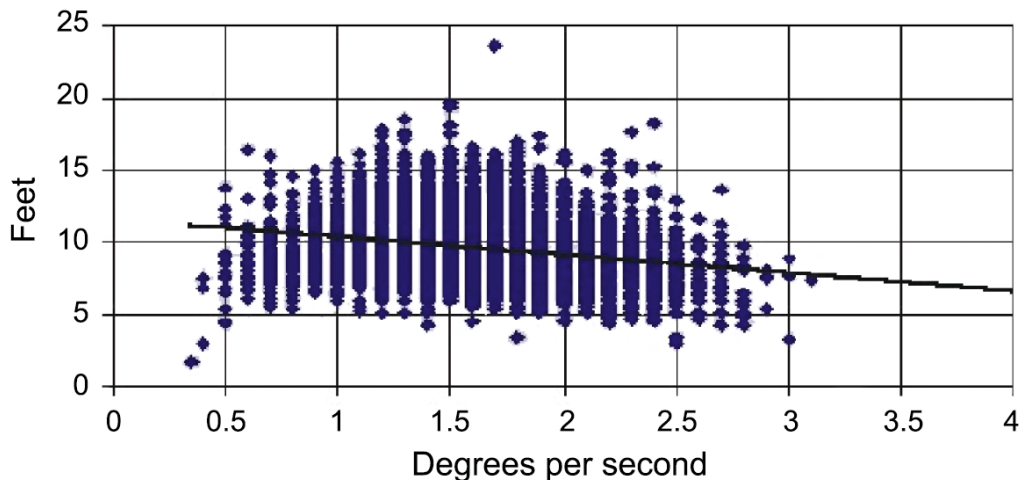
**Figure 4.3.B
Tail Clearance against Rotation Rate**

The small data sample (18 events, from 40 operators) does not facilitate meaningful trend analysis. There are no significant trends to tail strikes other than the majority (two-thirds) occurred on landing, and one third of the events involved a single aircraft type. There is no obvious reason for the predominance of this type, as others have a normal landing pitch attitude that is higher than this type. The incidents involving crew inexperience, tail wind landing conditions and late changes to a planned course of action illustrate the importance of extra vigilance and concentration required at critical stages of flight. Several incidents were not felt by the flight crew, but were reported by other observers, indicating that the strikes were very light. These incidents highlight the need for crews to monitor pitch angles on touchdown accurately. Flight Data Monitoring is regarded by the CWG as being vital for assisting with the prevention of Tail Strike accidents. Figure 4.3.B, showing tail clearance against rotation rate, indicates the type of information that may be obtained from a Flight Data Monitoring programme for use in flight crew training. Similar information for the landing scenario may also be obtained.

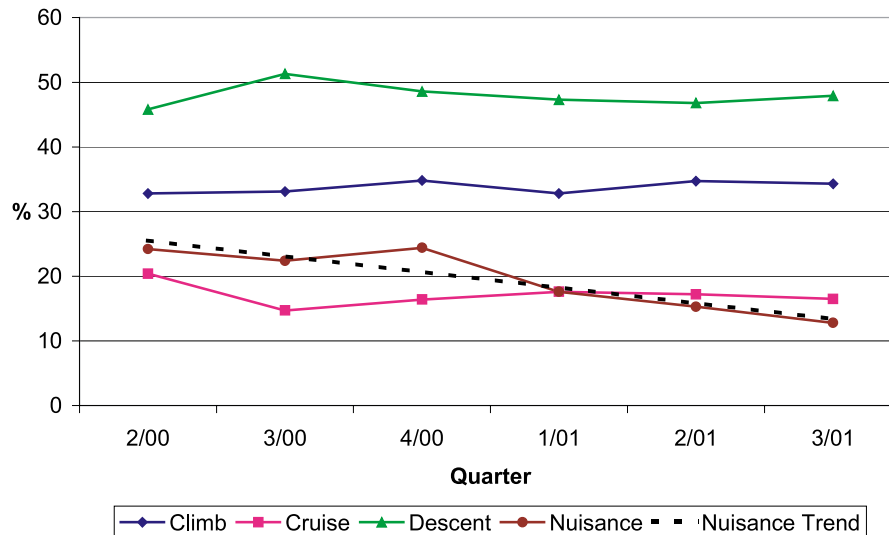
**Figure 4.3.D
TCAS Events From STEADES — April 2000 — September 2001**

The report was generated showing percentage of reports by generic Flight Phase (Climb, Cruise and Descent), plus the category of "nuisance" events (events which were filed under this category). The results of this study are shown at Figure 4.3.D.

It can be seen that over the period the percentages of Climb, Cruise and Descent events remained relatively static, while the percentage of nuisance events dropped from an average of 23.7% over the period April — December 2000 to 12.8% by September 2001, which was broadly in line with the reduction in reported events over the period. It can be seen that from the 4th quarter 2000 onwards there has been a gradual reduction in the number of TCAS events reports submitted, and a corresponding reduction in the number of “nuisance” events reported.

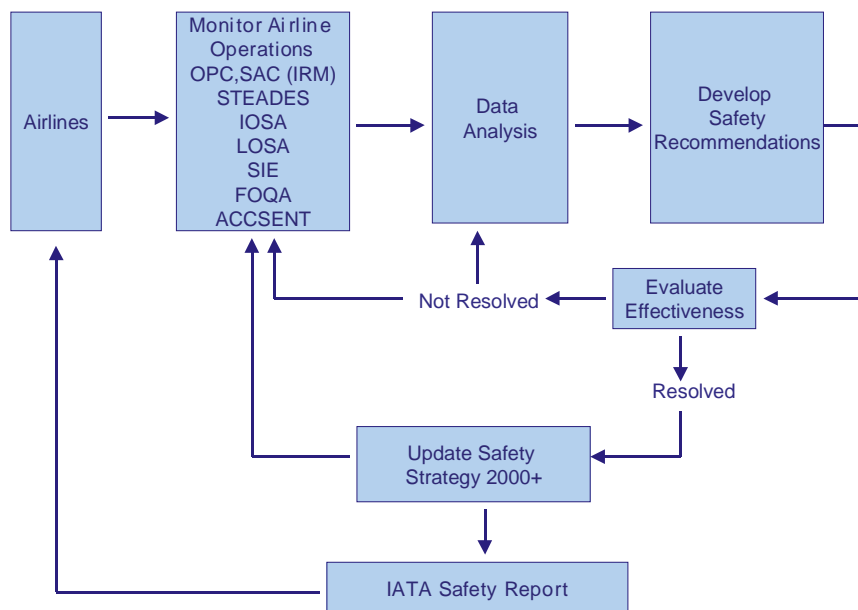
Figure 1
IATA Safety Management System

The role of the Safety Report is to document, analyse, comment and make recommendations of preventative measures regarding the airline industry's safety performance. The Safety Report is a key component of IATA's SMS that aims to monitor that safety performance in order to assist with accident prevention. Essentially the Safety Report is an exposition of IATA's SMS, refer to Figure 1 below.
