CFIT – Controlled Flight into Terrain

A Study of Terrain Awareness Warning System Capability and
Human Factors in CFIT Accidents 2005-2014

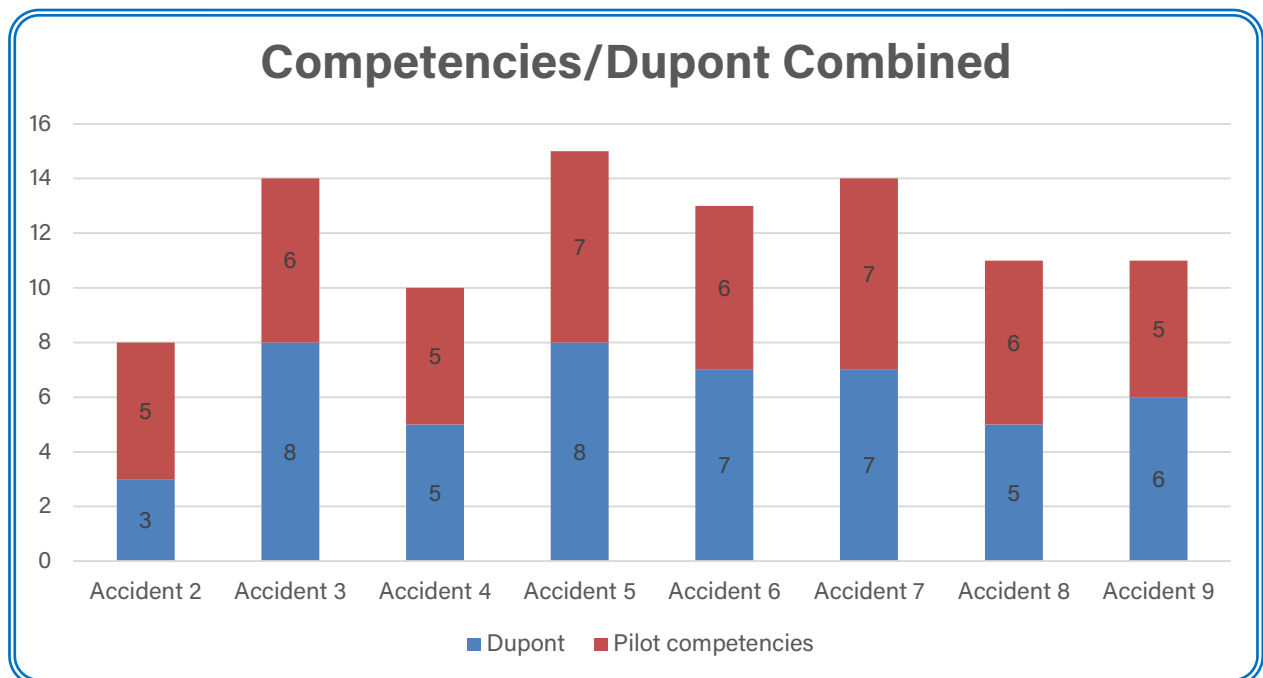
If we look at the total number of human performance deficiencies in the precursors to each accident, we see a high number, as can be seen on the following chart.

Chart 3 - combined precursors

It is worthy of note that neither model specifically addresses markers for Monitoring and/or Cross-checking, although *Lack of Awareness* and *Situational Awareness* respectively could be taken to include those competencies. Deficiencies in monitoring and cross-checking were apparent in several of the accidents. It is

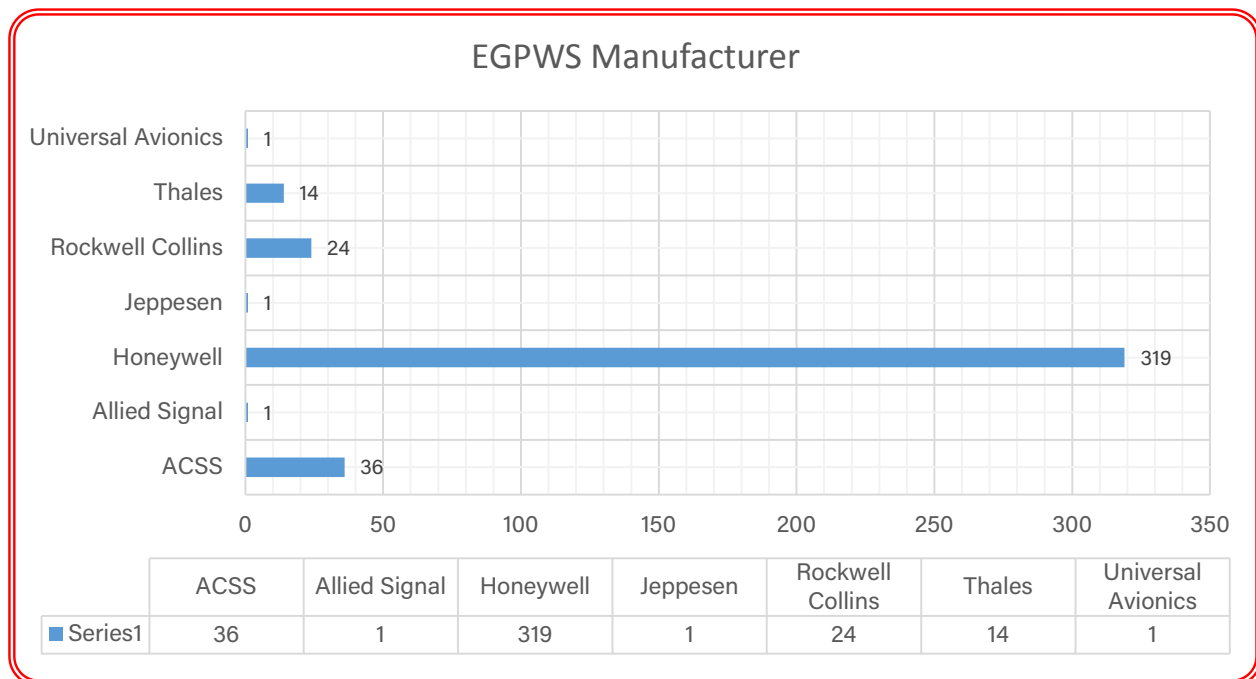
ACSS	9.1%	36
Allied Signal	0.3%	1
Honeywell	80.6%	319
Jeppesen	0.3%	1
Rockwell Collins	6.1%	24
Thales	3.5%	14
Universal Avionics	0.3%	1
		396

And graphically, we see it as follows:

We can see that the biggest majority of equipment fitted across all aircraft types is Honeywell, with over 80 percent of the fleets fitted with this equipment. As there was no investigation into incidents or correlation with events, there are no conclusions to be drawn from this and this merely represents a snapshot of manufacturers. No conclusions are drawn or implied.

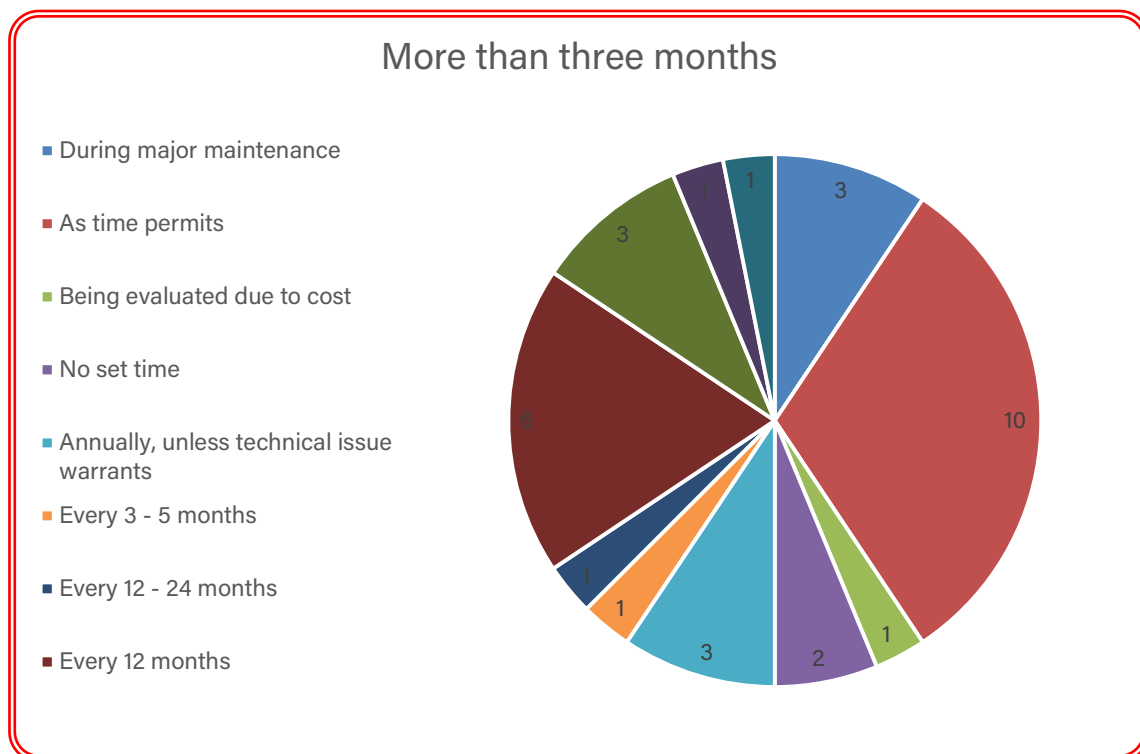
The breakdown of those that update in a period greater than 3 months, is as follows:

The important factor to consider here is that the manufacturer issues updates every three months. In order to ensure that the operator's terrain database is always up to date, these updates should be incorporated as
