USING DATA

for Preventive Maintenance of Embraer 190/195

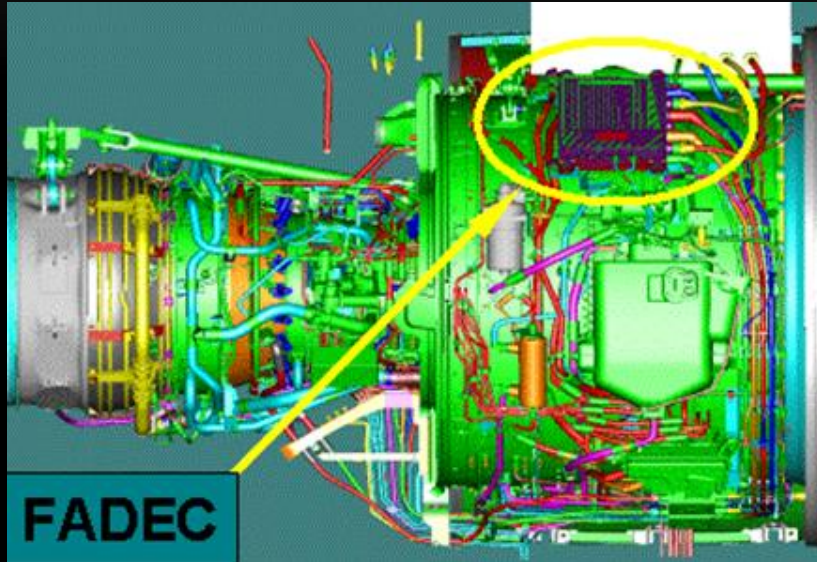
2. ENGINE FADEC

Full Authority Digital Electronic Control System controls the operation, performance and efficiency characteristics of the engine through full authority control over the entire engine fuel metering unit, variable stator vanes, operability bleed valve, T2 sensor heater, thrust reverser actuation, engine starting, ignition and also providing engine limit protection during ground starts.

- Engine FADEC 1 (no dispatch) \Leftrightarrow FADEC 2
- 7 days both worked properly
- A new fault message appeared (FIM executed \rightarrow wire and sensor both ok, so only FADEC according to FIM)
- Solution – to replace FADEC?
