15<sup>th</sup> Maintenance Cost Conference  
Athens, Greece  
18-19 September 2019

**“Science @ MCC”**

- **“The NDTonAIR” project**
- **Investigated applications**
  - Ultrasonic Inspection
    - ☞ Wing Gear Rib 6 Crack in the A33F
  - Active Thermography
    - ☞ Water ingress
    - ☞ RR Air Intake Noise Panel
    - ☞ Loose rivets
- **Future works and Conclusions**

# Wing Gear Rib 6 Crack in the A33F - AIRBUS

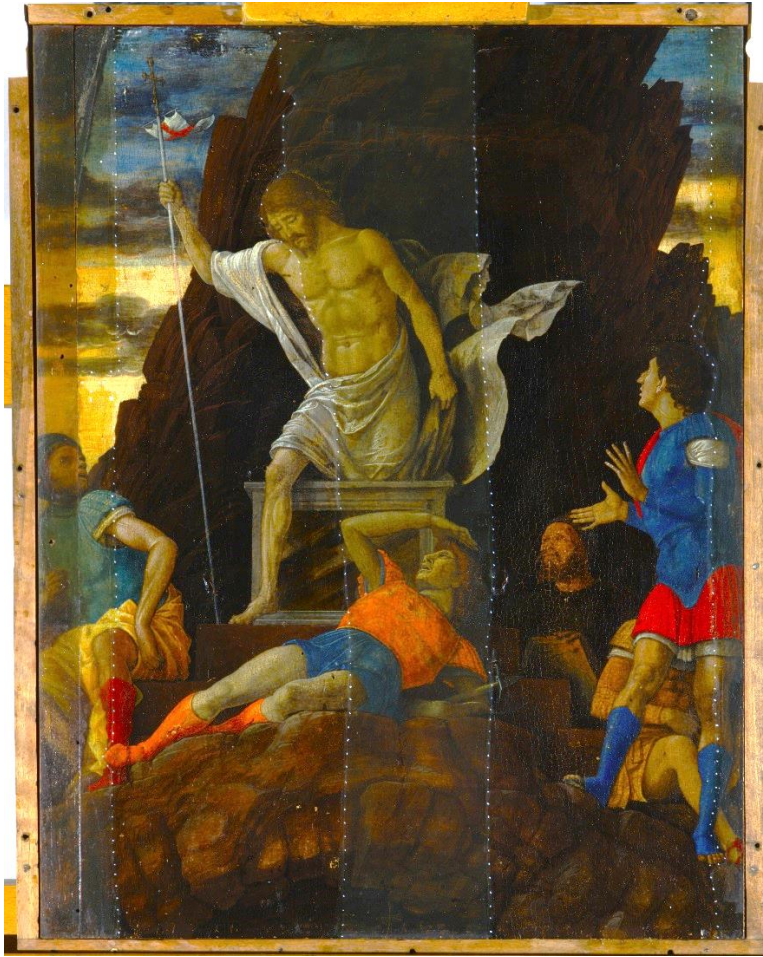
## Pulse-compression Thermography example

Many indications from time-analysis of thermograms: wood grain structure, nails & grouts, cracks, preparation layer

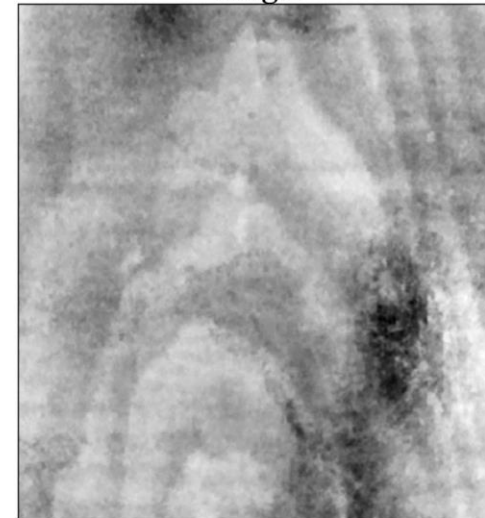
Angle

$T = 0.35 \text{ s}$

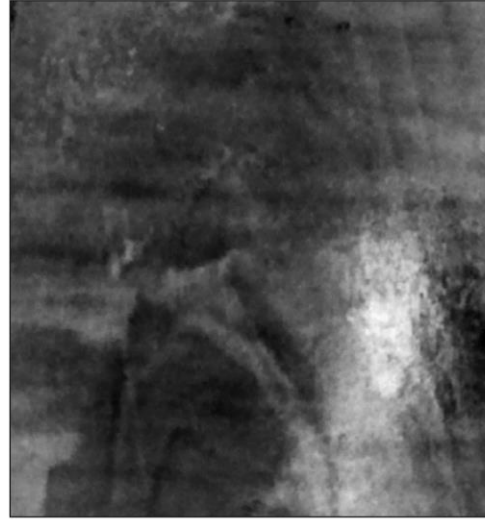
Real

# Water Ingress detection with Thermography

$T = 0.60 \text{ s}$

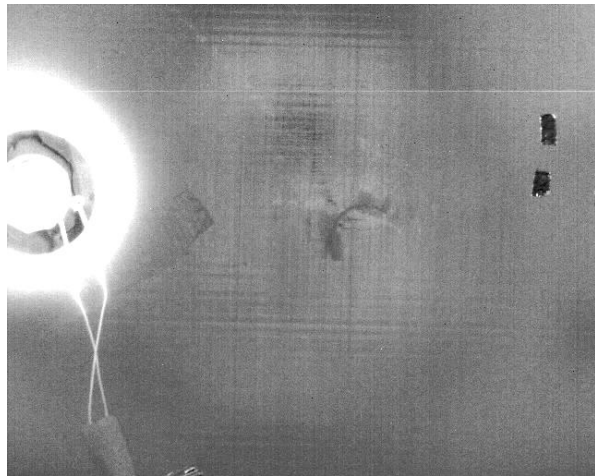
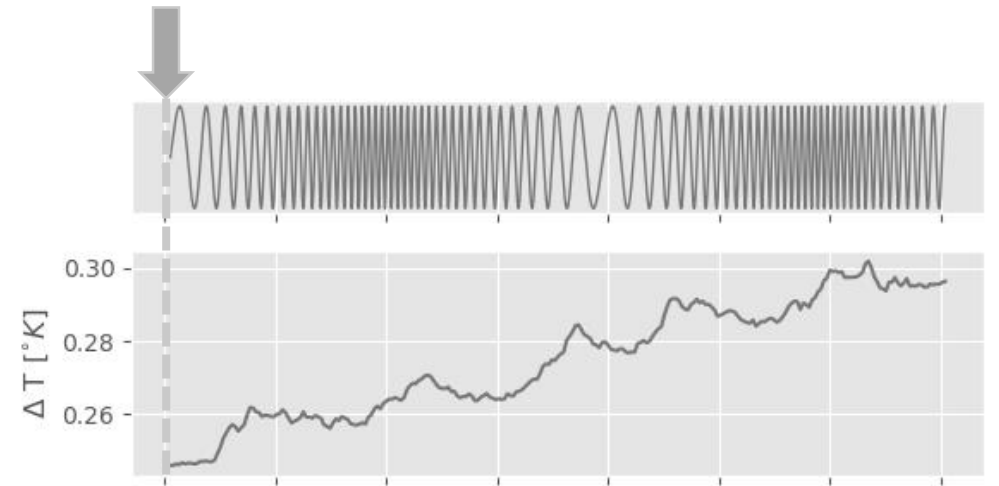
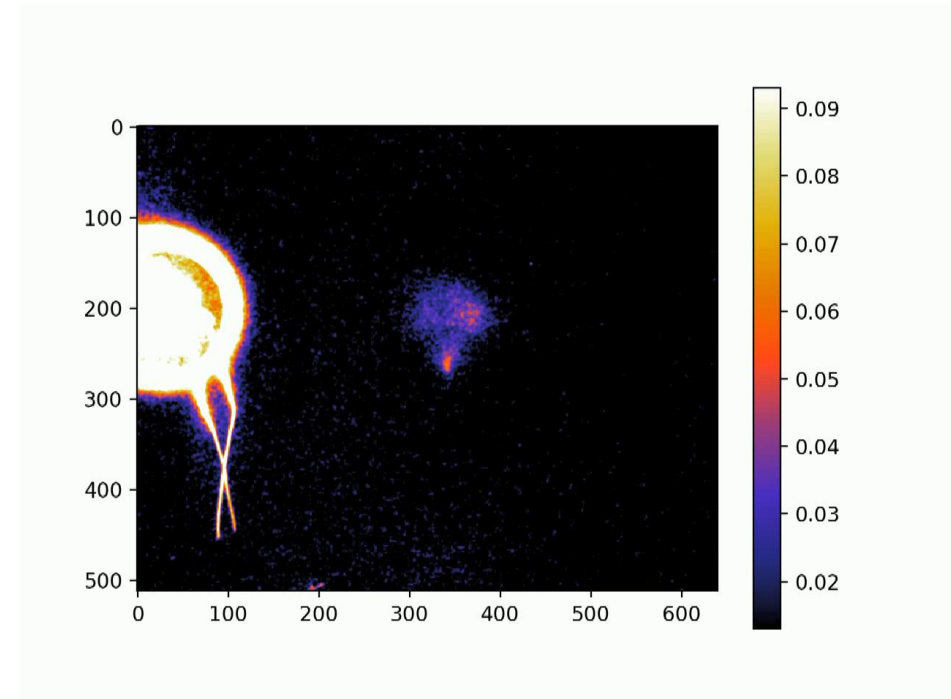
- FLIR SC7000
- Glued PZT
- Sweep: 15-25 kHz
- 10 images averaged

- Pulse-compression Phased Array for Rib inspection without LG removal
- Pulse-compression Thermography for water and noise panel inspection
- Ultrasonic-stimulated Thermography for loose rivets
